Re: Geotechnical Engineering Review
35% Plan Review
Corte Madera 4-acre Marsh Restoration
Corte Madera, California

This report summarizes the results of the Geotechnical Investigation for the planned Wetland Restoration Design and Permitting Support Services at Corte Madera Ecological Reserve, Professional Service Agreement PSA No. 2014-FT-13, in Corte Madera, California. The project site is located on the eastern side of Corte Madera, adjacent to San Francisco Bay, as shown on Figure 1. The purpose of this investigation is to evaluate existing geologic and geotechnical site conditions, including stability of existing levees and slope stability of proposed breached levee end-points, and prepare preliminary geotechnical recommendations for use in project planning and design.

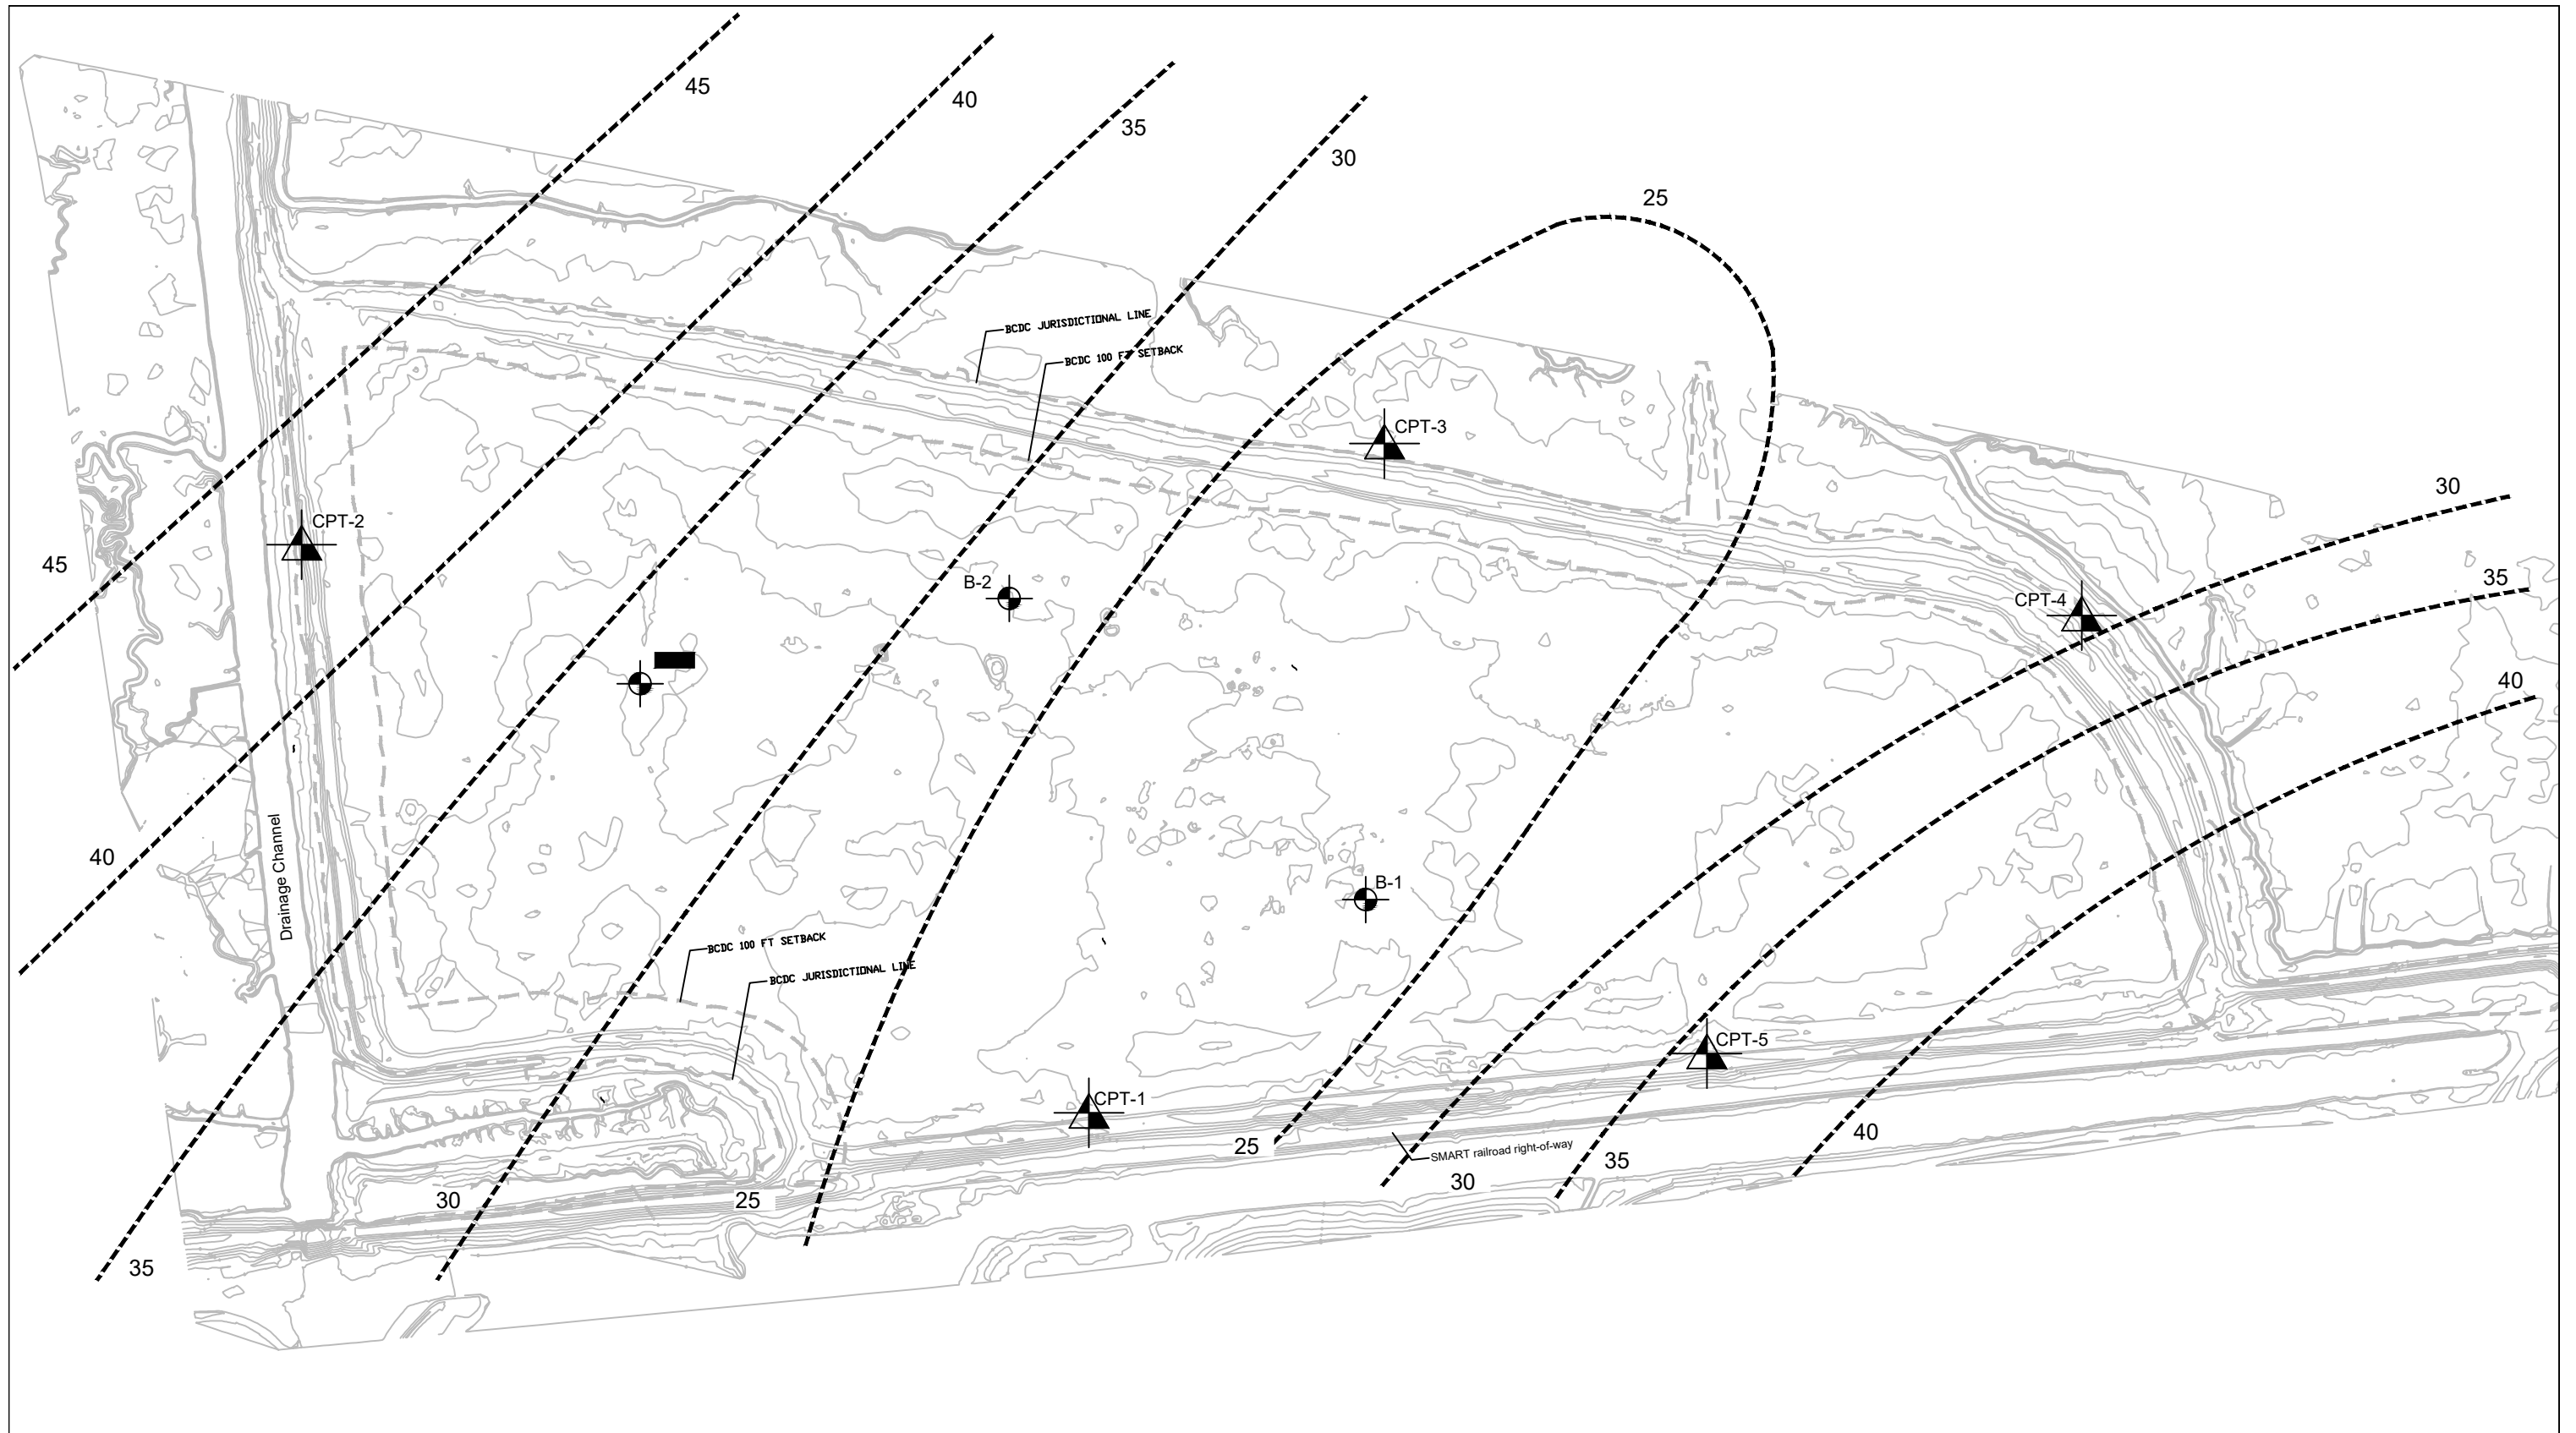
Miller Pacific ENGINEERING GROUP	504 Redwood Blvd. Suite 220 Novato, CA 94947 T 415 / 382-3444 F 415 / 382-3450 www.millerpac.com	SITE PLAN WITH BAY MUD CONTOURS	
	A CALIFORNIA CORPORATION, © 2010, ALL RIGHTS RESERVED FILE: 1039.051 Alternative 1.dwg		Wetland Restoration Design and Permitting Support Services at Corte Madera Ecological Reserve, PSA 2014-FT-13 Project No. 1039.051 Date: 10-8-15

Subsurface conditions across the site generally confirm the regionally-mapped geology. Approximately 5 to 10-feet of sandy silty clay fill material exists above approximately 20 to 40-feet of bay mud, followed by medium stiff to stiff alluvial clays that extend in excess of 50-feet below the ground surface. Exploration did not extend beyond 50-feet. The interpreted thickness of the bay mud layer varies across the site as shown on Figure 2. The existing perimeter levee is composed of medium stiff, clayey soils that transition to soft bay mud at a depth of about 10 feet. CPT and boring logs are attached in Appendix A.

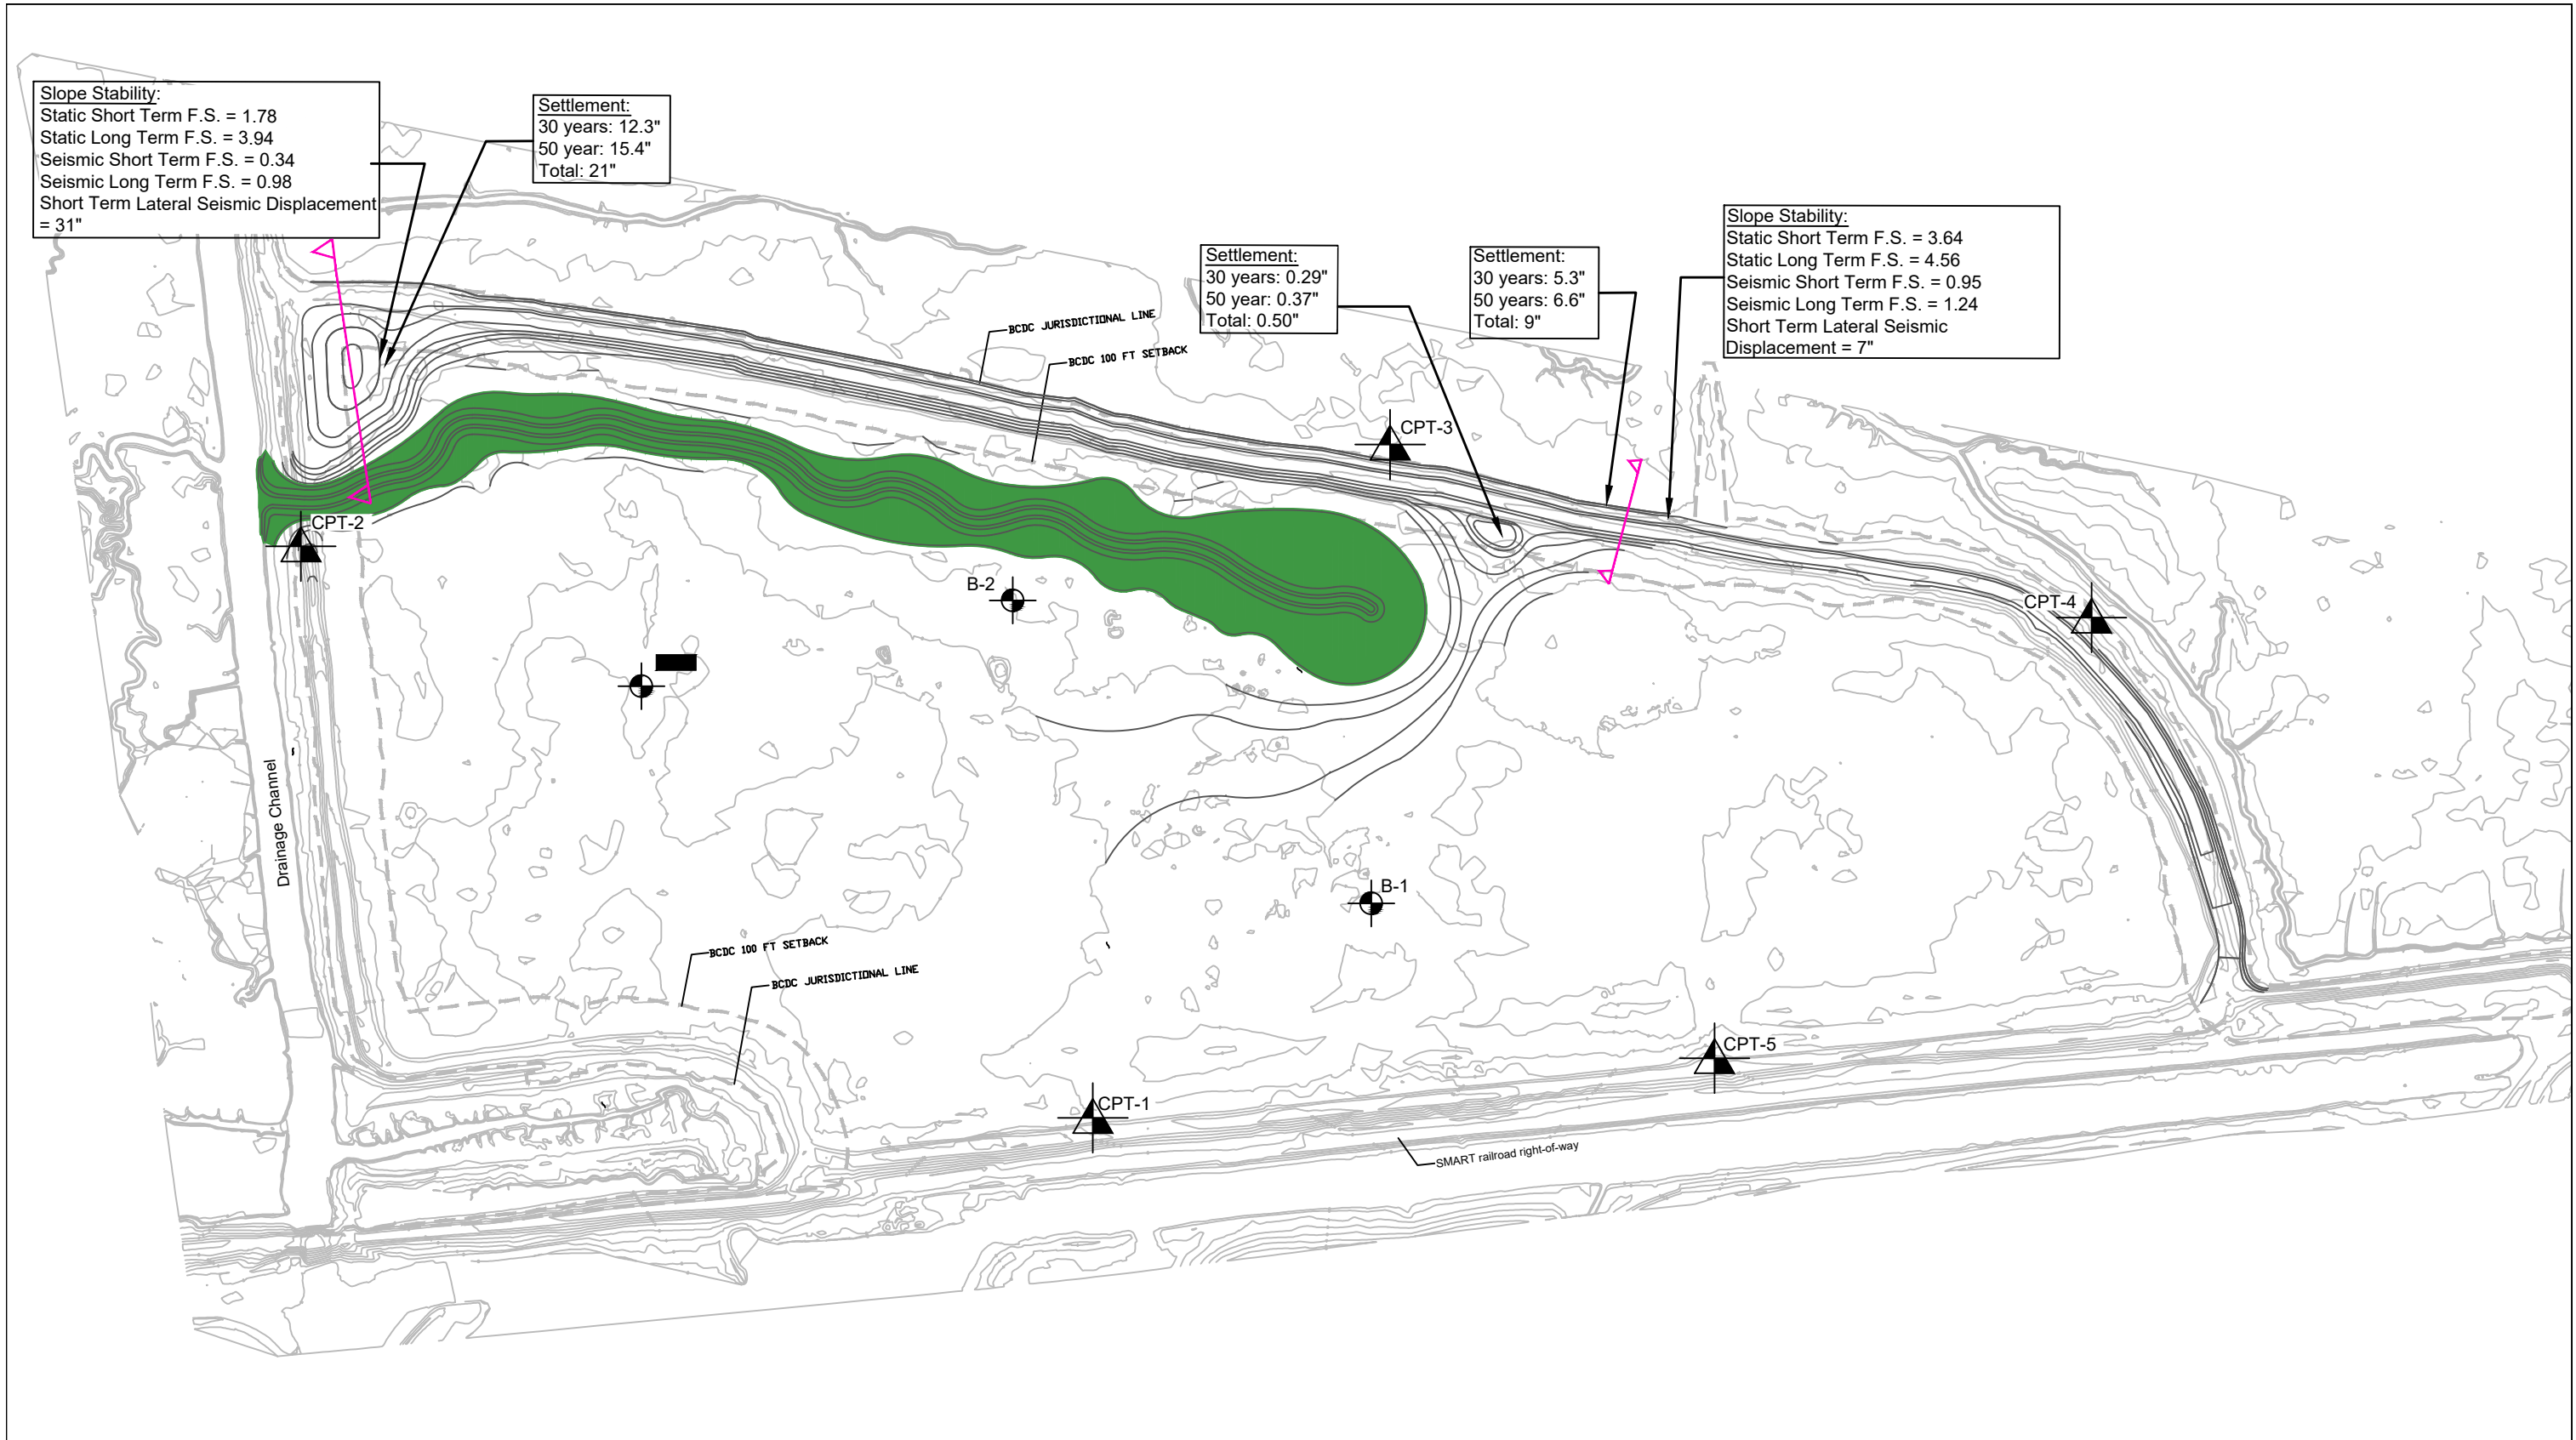
- Approximate location of boring completed by MPEG.
- Approximate location of CPT completed by MPEG.

Miller Pacific ENGINEERING GROUP	504 Redwood Blvd.	ALTERNATIVE 1B SITE PLAN	
	Suite 220		
	Novato, CA 94947	Wetland Restoration Design and Permitting Support Services at Corte Madera Ecological Reserve, PSA 2014-FT-13	
	T 415 / 382-3444		
	F 415 / 382-3450	Drawn <u>MMT</u> Checked	3 FIGURE
A CALIFORNIA CORPORATION, © 2010, ALL RIGHTS RESERVED FILE: 1039.051 Alternative 1.dwg	www.millerpac.com	Project No. 1039.051	Date: 10-8-15

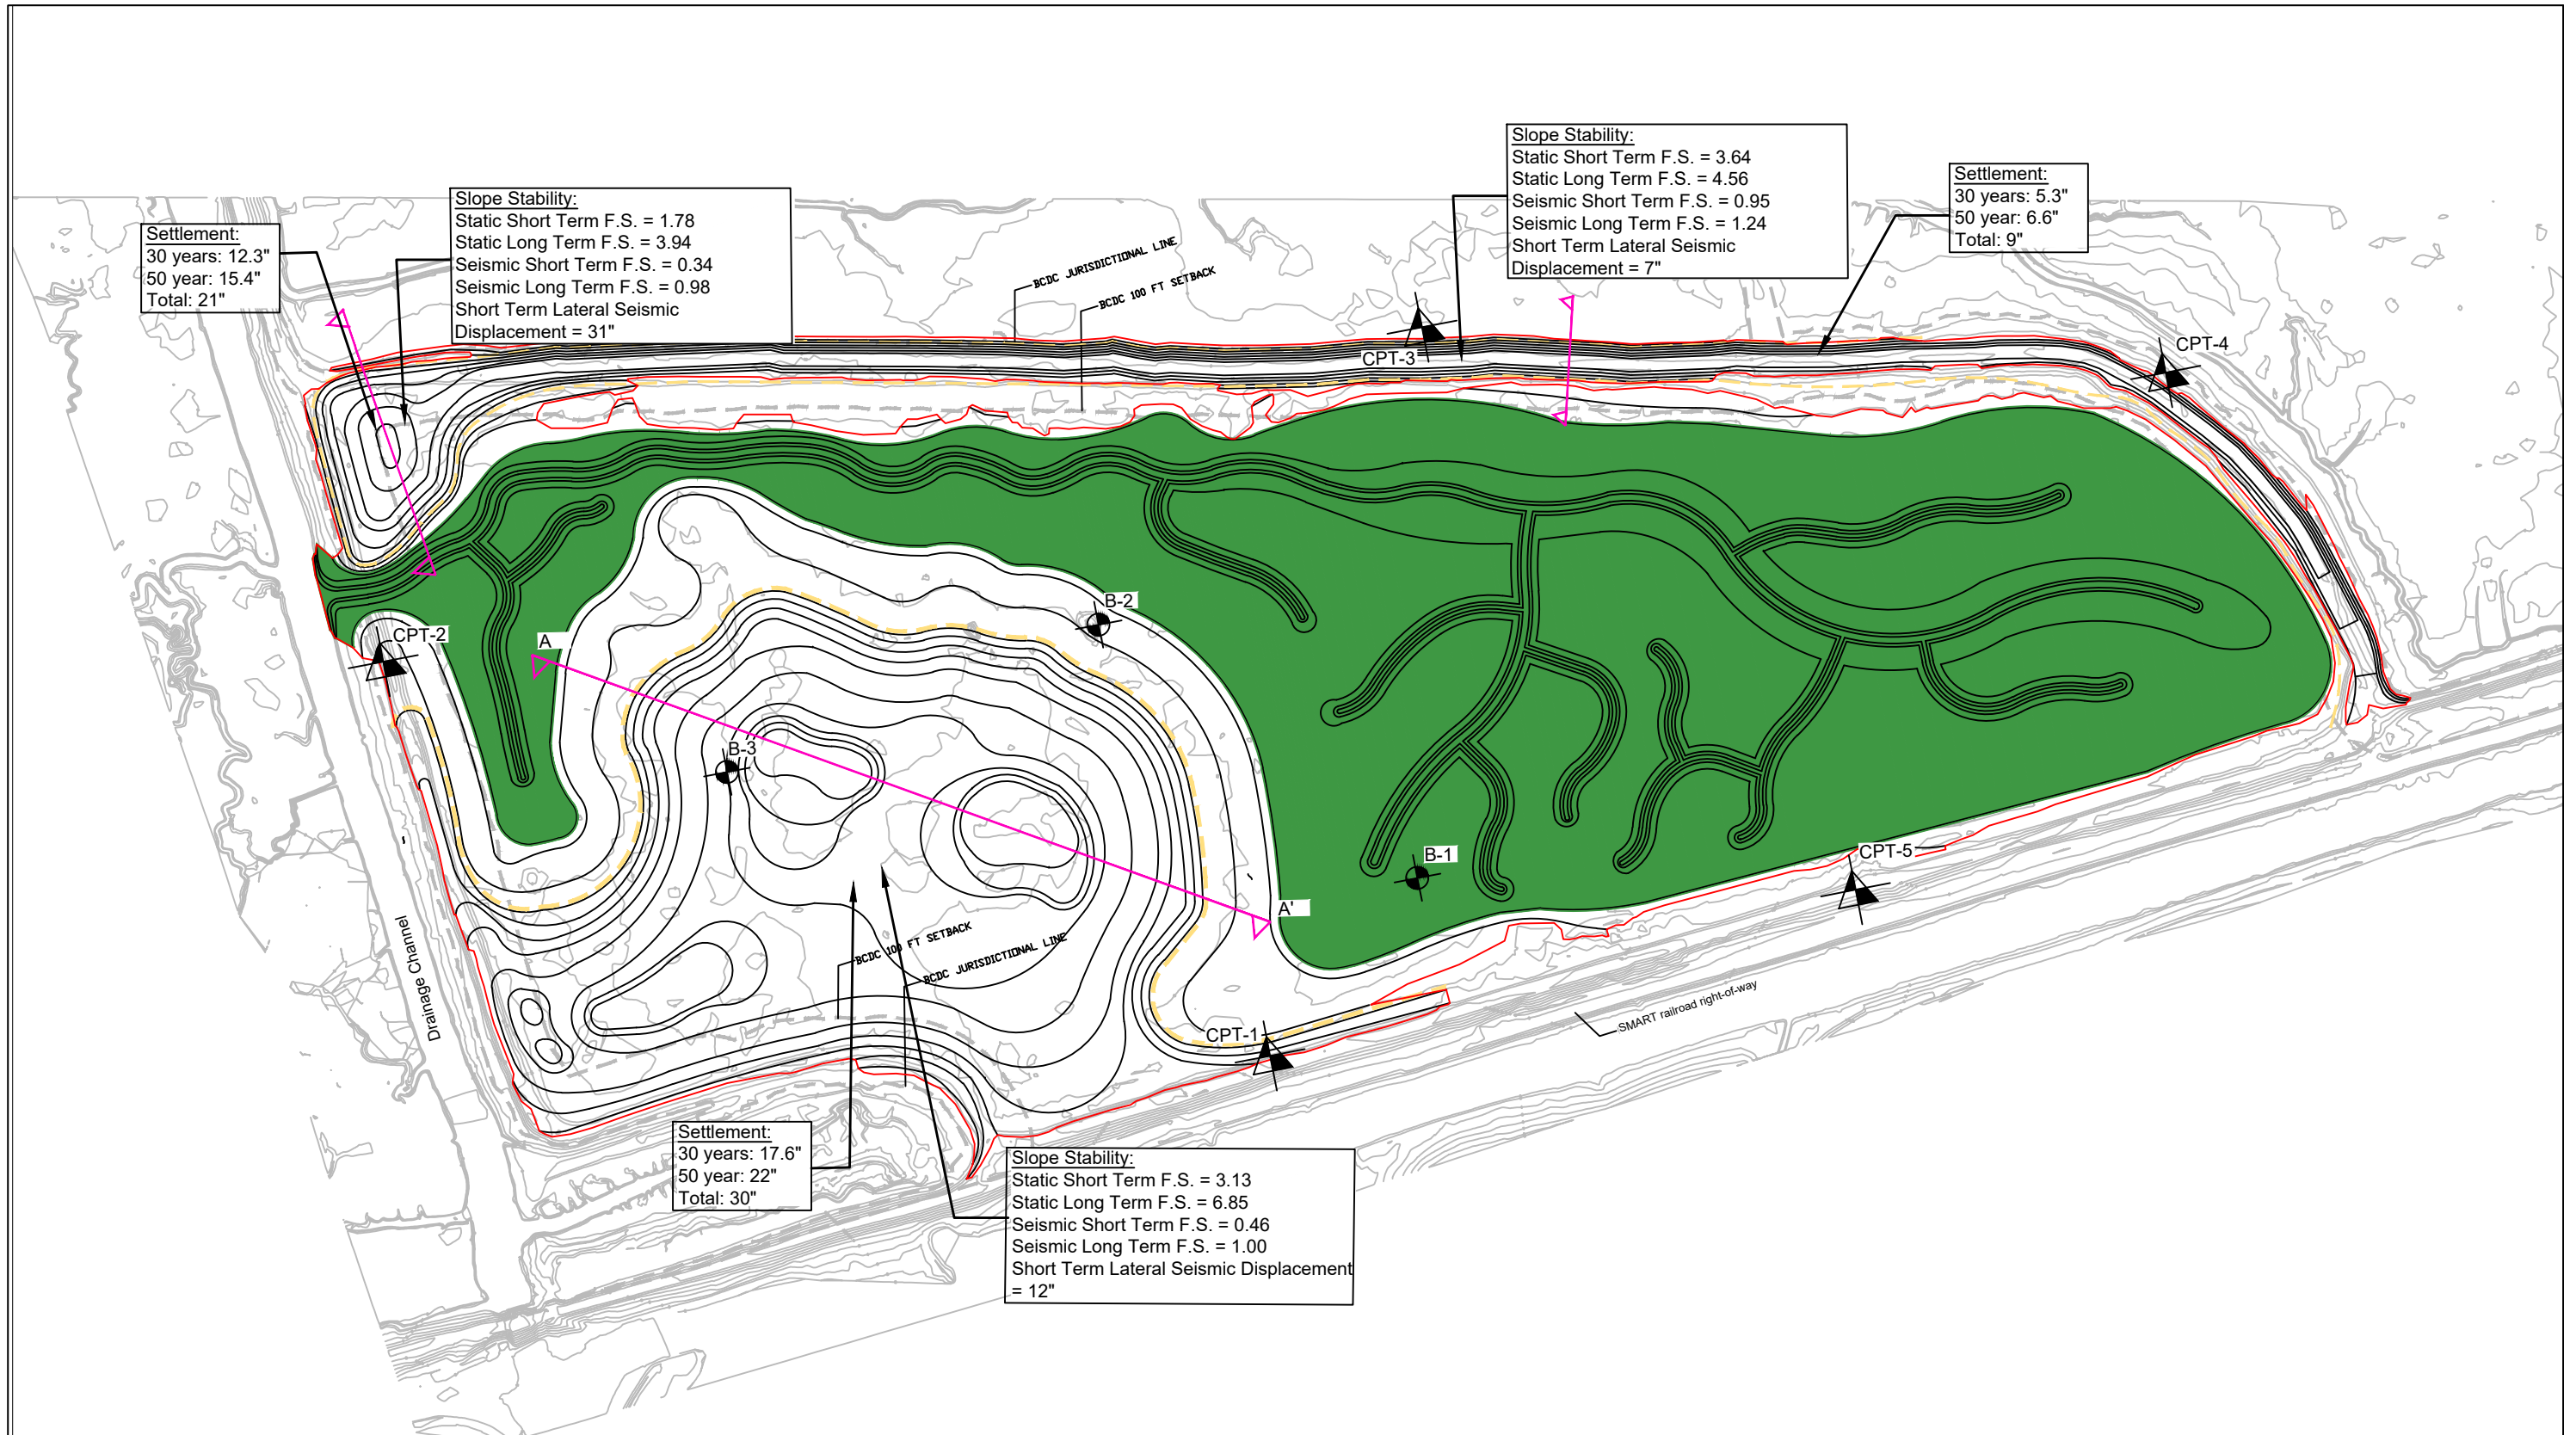
- Approximate location of boring completed by MPEG.
- Approximate location of CPT completed by MPEG.

Miller Pacific ENGINEERING GROUP <small>A CALIFORNIA CORPORATION. © 2013, ALL RIGHTS RESERVED AutoCAD file number: Alternative 2A.dwg</small>	504 Redwood Blvd. Suite 220 Novato, CA 94947 T 415 / 382-3444 F 415 / 382-3450 www.millerpac.com	ALTERNATIVE 2A SITE PLAN	
	Wetland Restoration Design and Permitting Support Services at Corte Madera Ecological Reserve, PSA 2014-FT-13 Project No. 1039.051 Date: 8-28-15	Designed <u>SAS</u> Drawn <u>MMT</u> Checked _____	4 FIGURE

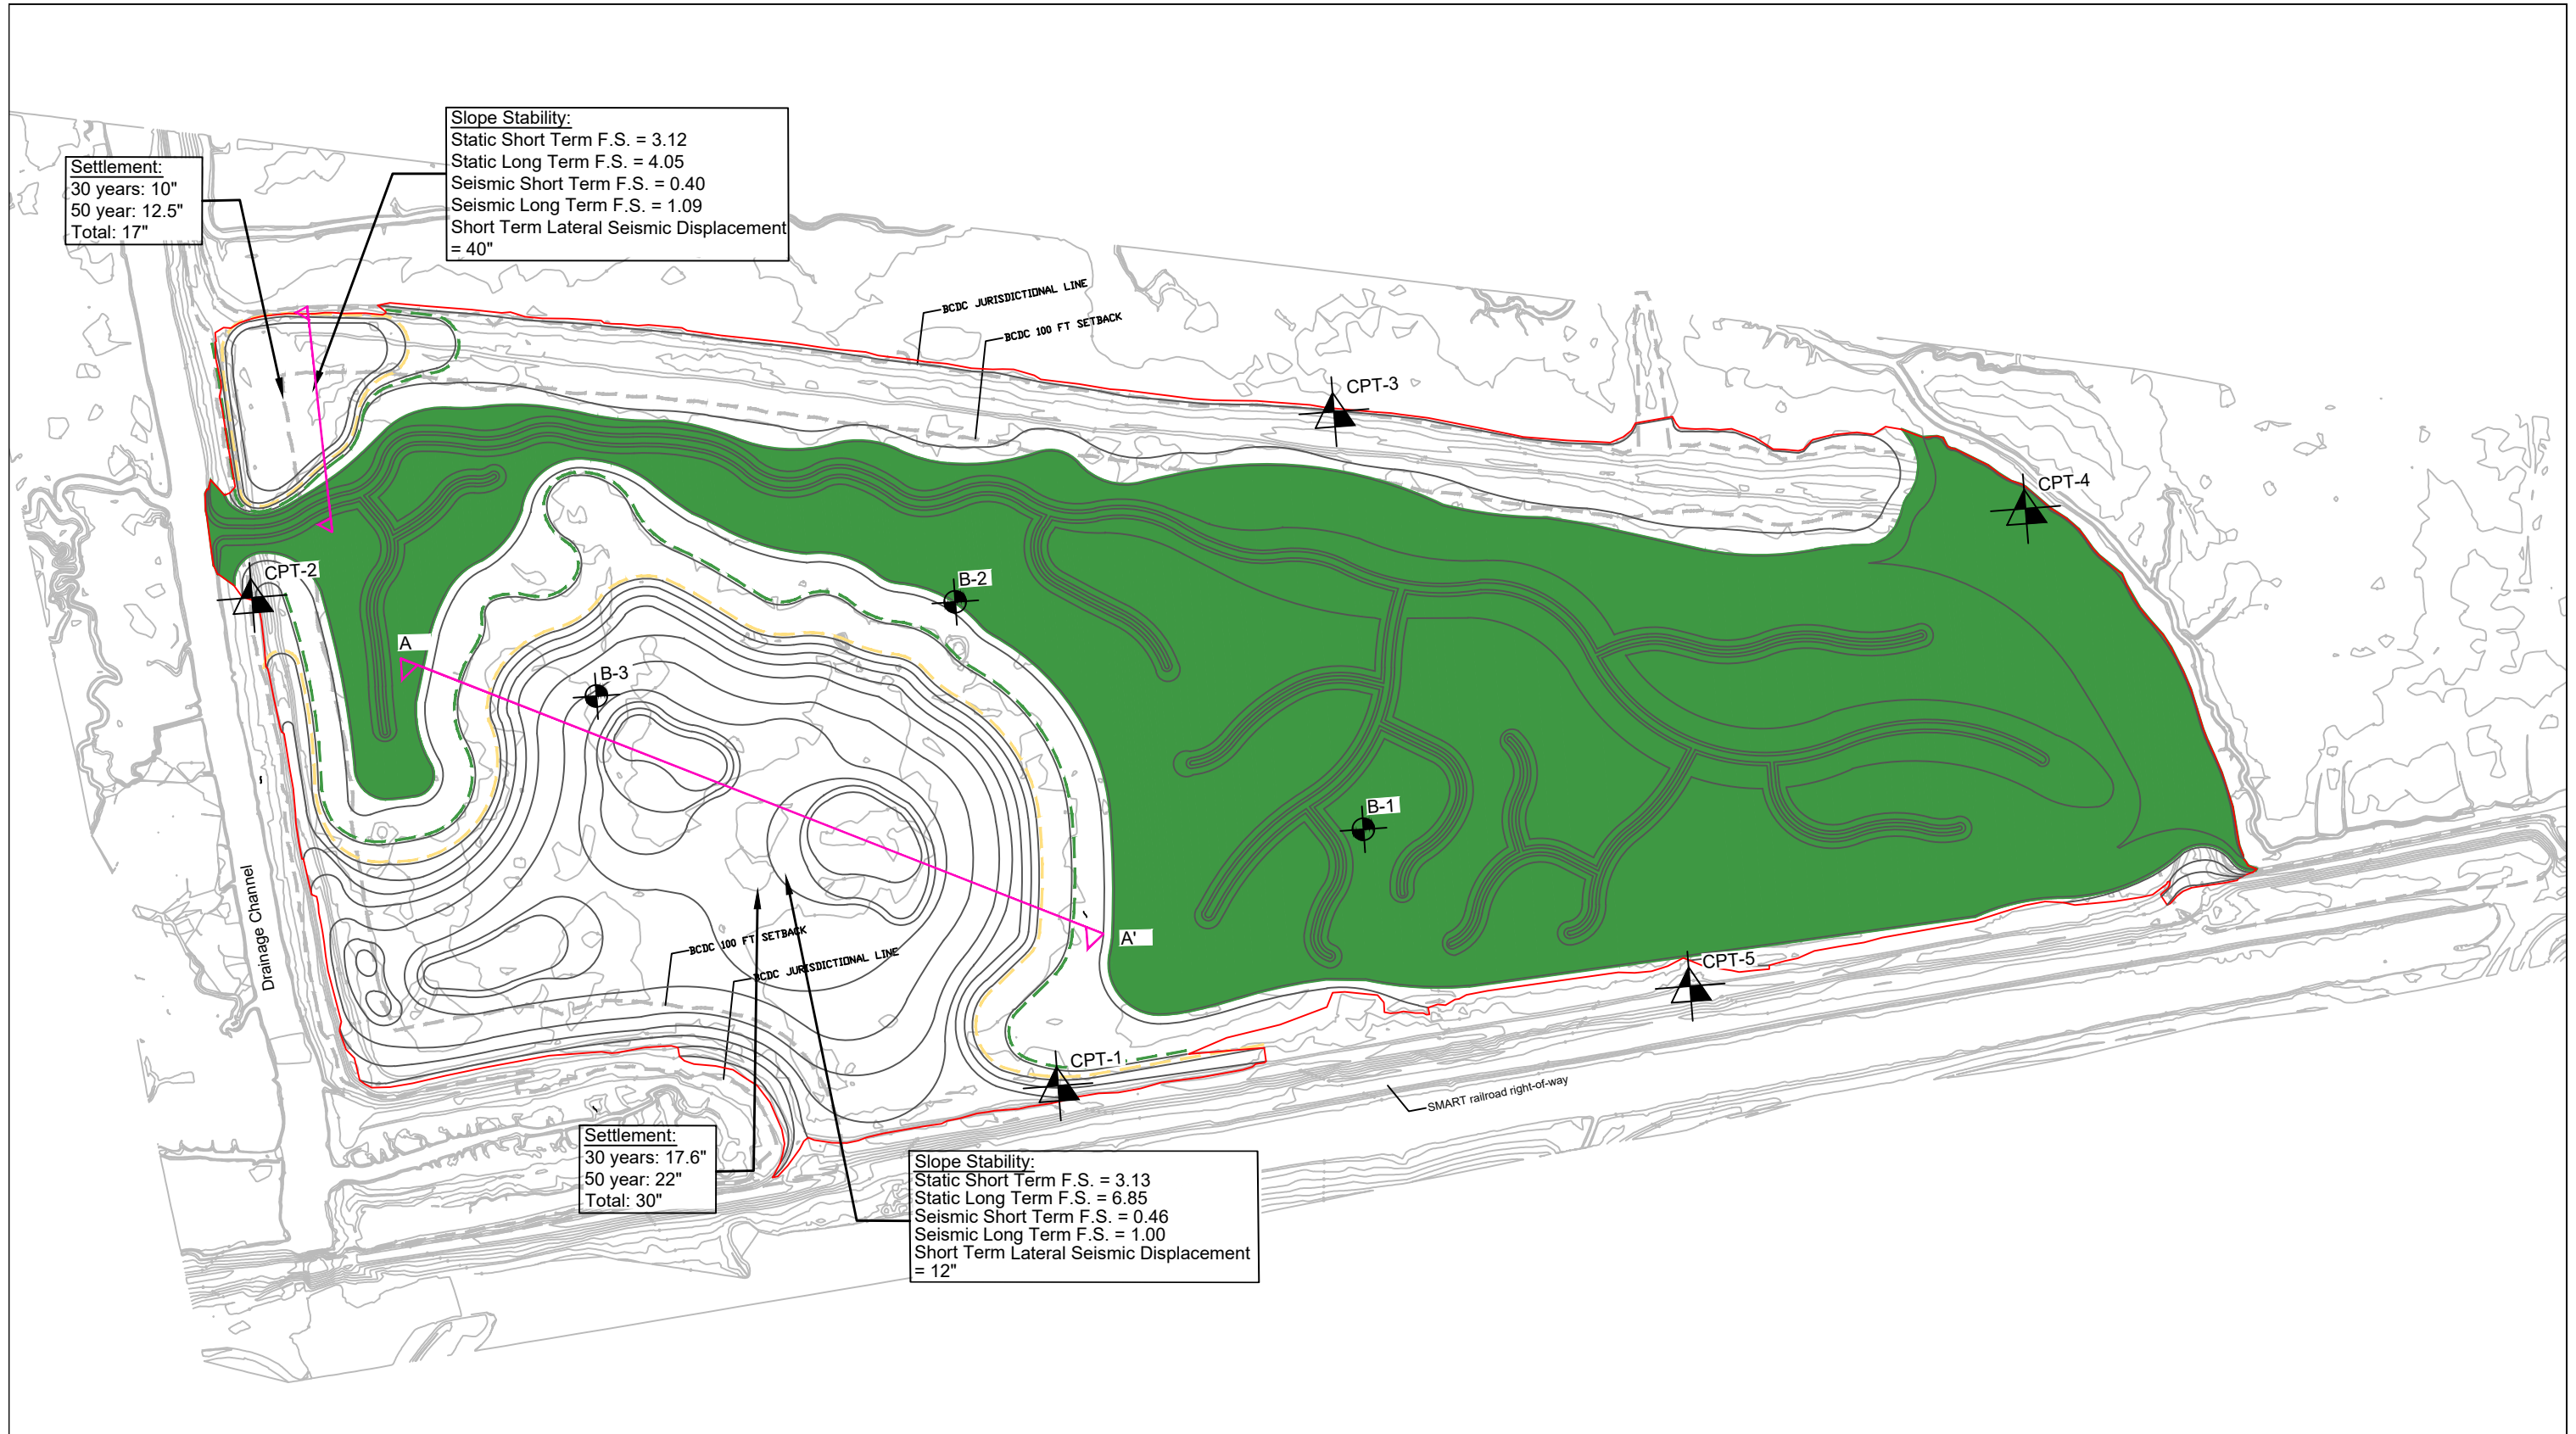
Miller Pacific ENGINEERING GROUP	504 Redwood Blvd. Suite 220 Novato, CA 94947 T 415 / 382-3444 F 415 / 382-3450 www.millerpac.com		ALTERNATIVE 2B	
	A CALIFORNIA CORPORATION, © 2010, ALL RIGHTS RESERVED FILE: 1039.051 Alternative 2B.dwg		Wetland Restoration Design and Permitting Support Services at Corte Madera Ecological Reserve, PSA 2104-FT-13 Project No. 1039.051 Date: 10-8-15	
			Drawn MMT Checked	5 FIGURE

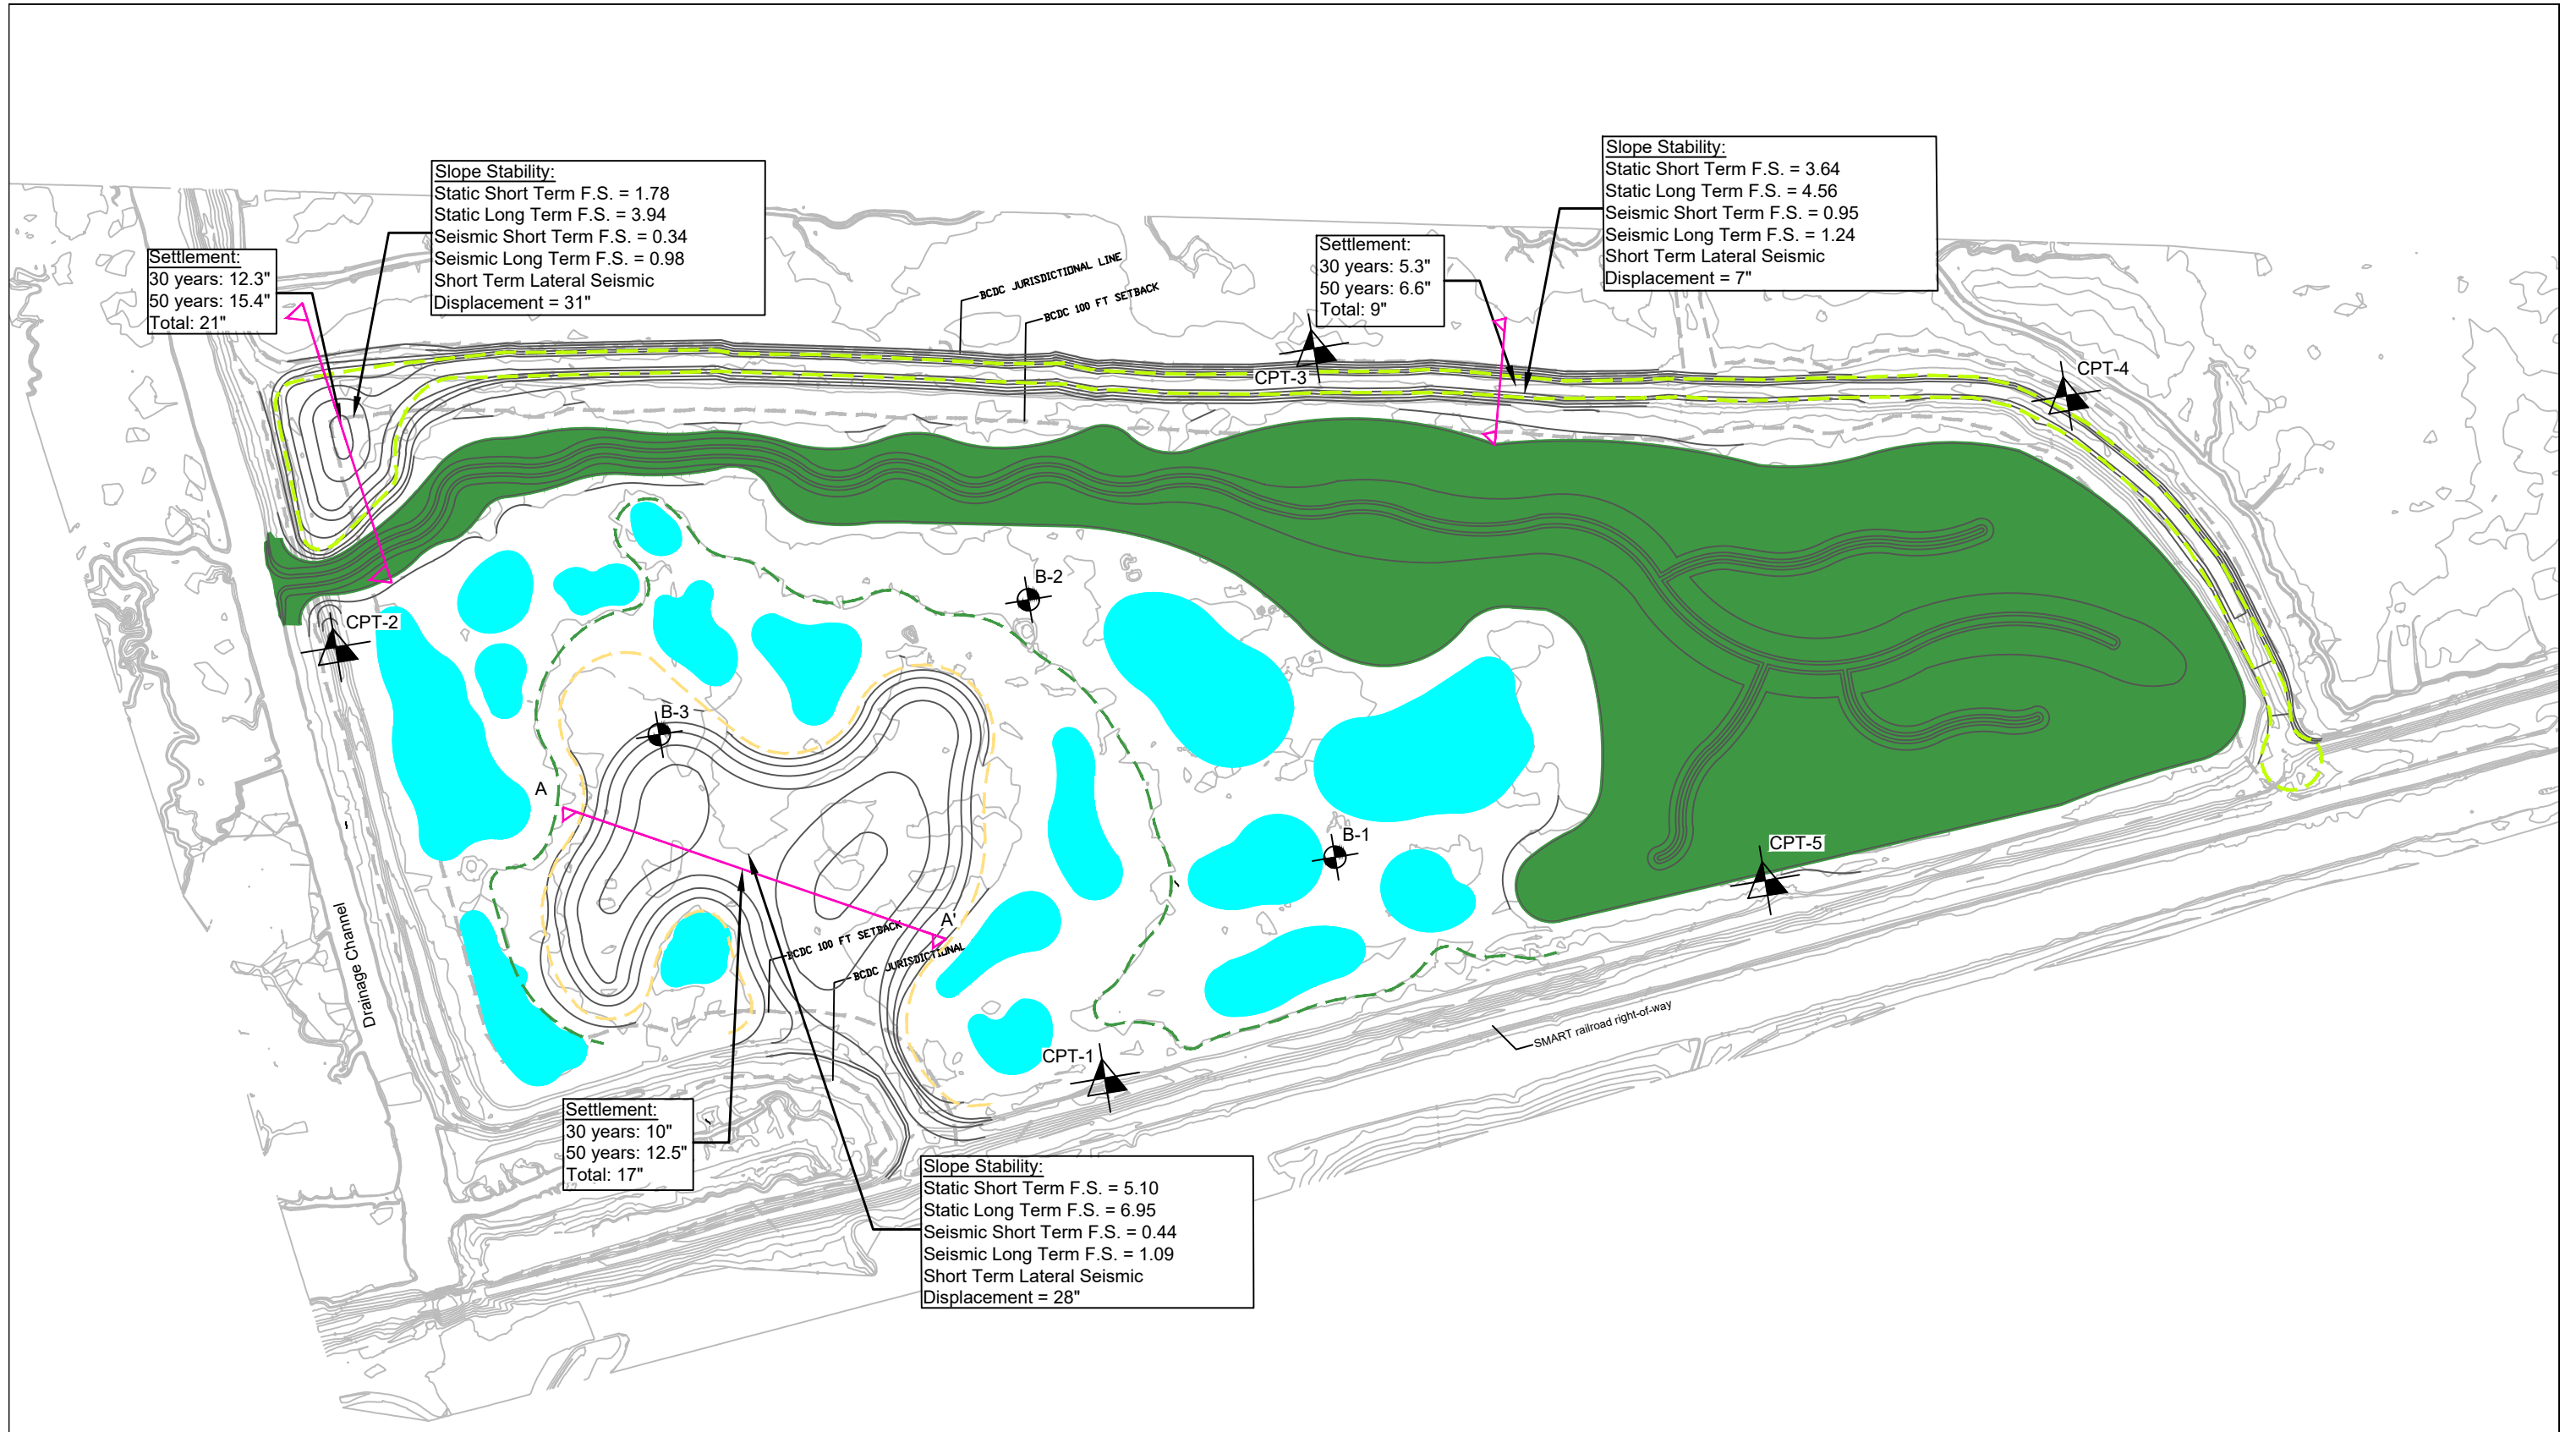
- Approximate location of boring completed by MPEG.
- Approximate location of CPT completed by MPEG.

Miller Pacific ENGINEERING GROUP	504 Redwood Blvd.	ALTERNATIVE 3A SITE PLAN	
	Suite 220		
	Novato, CA 94947	Wetland Restoration Design and Permitting Support Services at Corte Madera Ecological Reserve, PSA 2014-FT-13	
	T 415 / 382-3444		
	F 415 / 382-3450	Project No. 1039.051 Date: 10-6-15	
	www.millerpac.com		
A CALIFORNIA CORPORATION, © 2010, ALL RIGHTS RESERVED FILE: 1039.051 Alternative 3A.dwg		Drawn MMT Checked	6 FIGURE
