Re: Geotechnical Engineering Review
35% Plan Review
Corte Madera 4-acre Marsh Restoration
Corte Madera, California

This report summarizes the results of the Geotechnical Investigation for the planned Wetland Restoration Design and Permitting Support Services at Corte Madera Ecological Reserve, Professional Service Agreement PSA No. 2014-FT-13, in Corte Madera, California. The project site is located on the eastern side of Corte Madera, adjacent to San Francisco Bay, as shown on Figure 1. The purpose of this investigation is to evaluate existing geologic and geotechnical site conditions, including stability of existing levees and slope stability of proposed breached levee end-points, and prepare preliminary geotechnical recommendations for use in project planning and design.

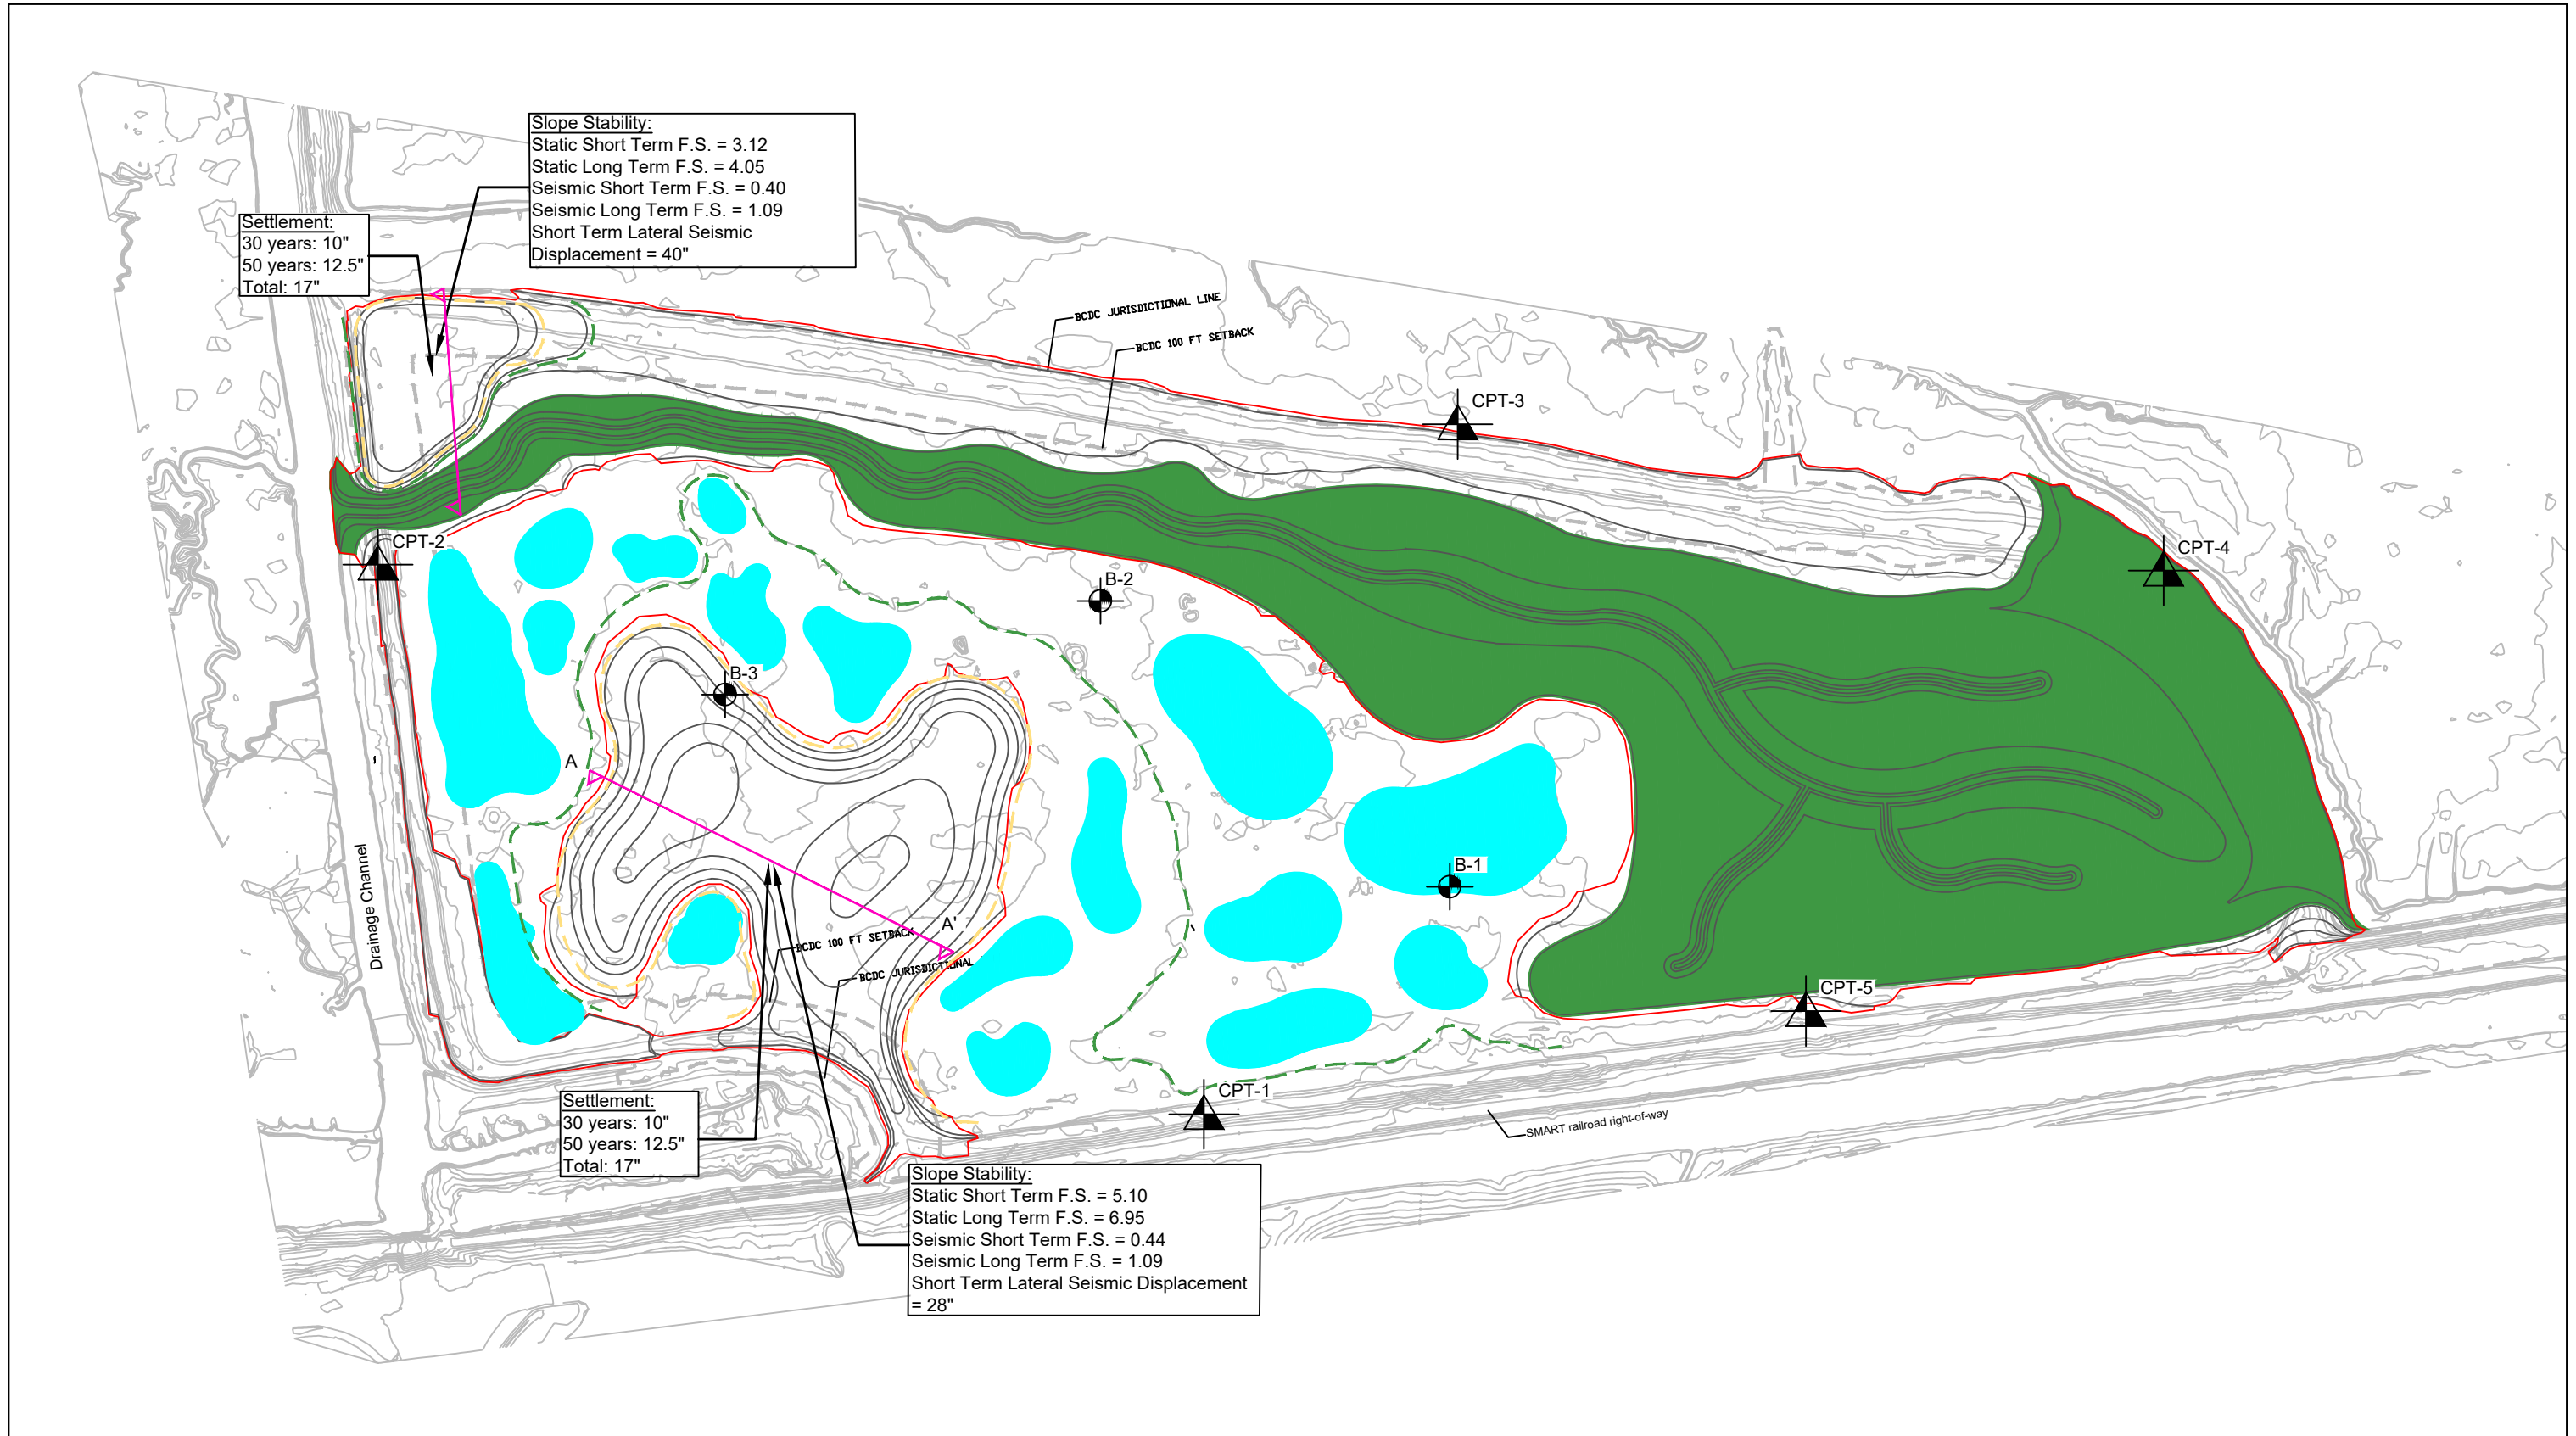
- Approximate location of boring completed by MPEG.
- Approximate location of CPT completed by MPEG.

Miller Pacific ENGINEERING GROUP	504 Redwood Blvd.	ALTERNATIVE 3B SITE PLAN	
	Suite 220		
A CALIFORNIA CORPORATION, © 2010, ALL RIGHTS RESERVED	Novato, CA 94947	Wetland Restoration Design and Permitting Support Services at Corte Madera Ecological Reserve, PSA 2014-FT-13	
FILE: 1039.051 Alternative 3B.dwg	T 415 / 382-3444		
	F 415 / 382-3450	Checked	<div style="font-size: 2em; font-weight: bold;">7</div> FIGURE
	www.millerpac.com	Project No. 1039.051 Date: 10-8-15

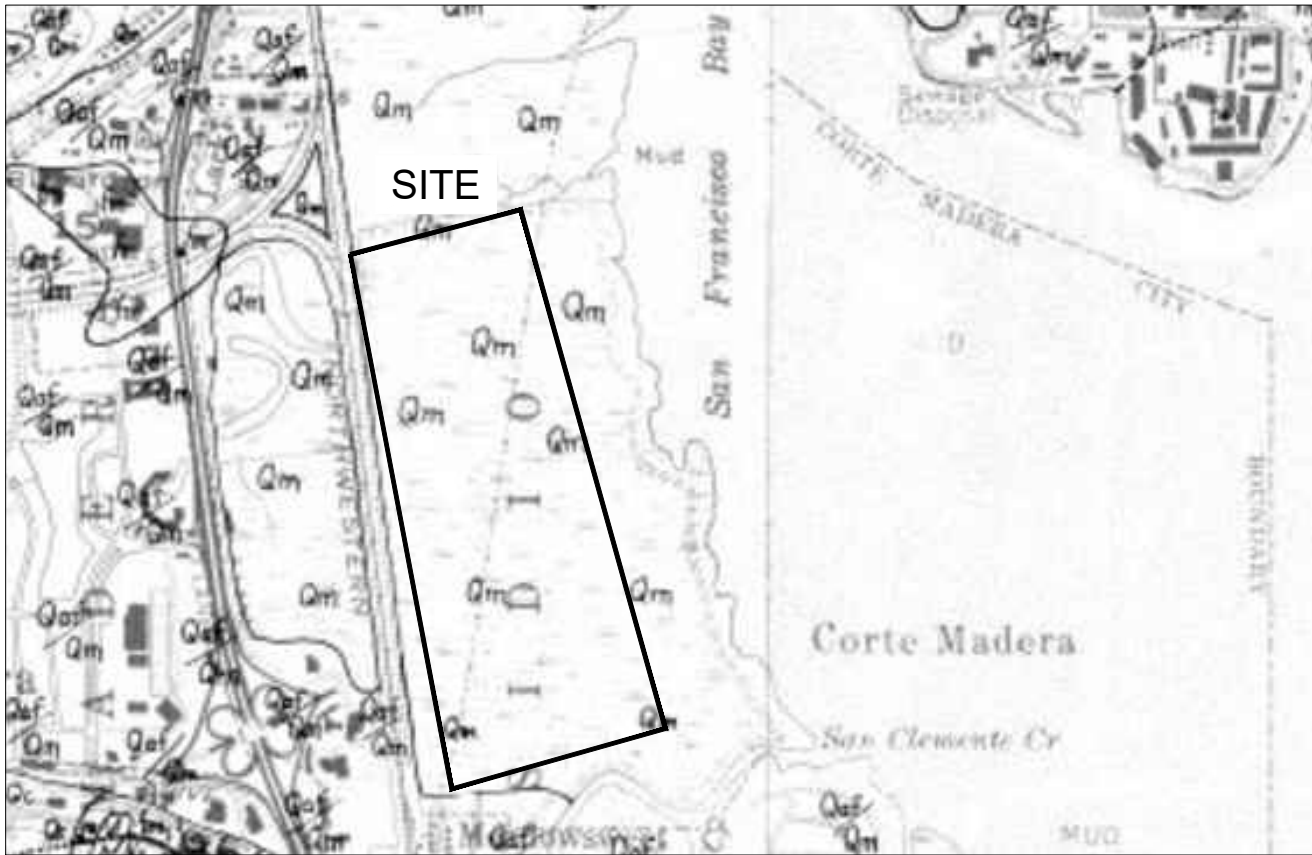
<p>Miller Pacific ENGINEERING GROUP</p>	504 Redwood Blvd. Suite 220 Novato, CA 94947 T 415 / 382-3444 F 415 / 382-3450 www.millerpac.com	REGIONAL GEOLOGIC MAP		<div style="font-size: 2em; font-weight: bold; margin: 0;">8</div> <p>FIGURE</p>
	Wetland Restoration Design and Permitting Support Services at Corte Madera Ecological Reserve, PSA 2014-FT-13		Drawn _____ MMT Checked _____	
A CALIFORNIA CORPORATION, © 2014, ALL RIGHTS RESERVED File: 1039.051 GM.dwg

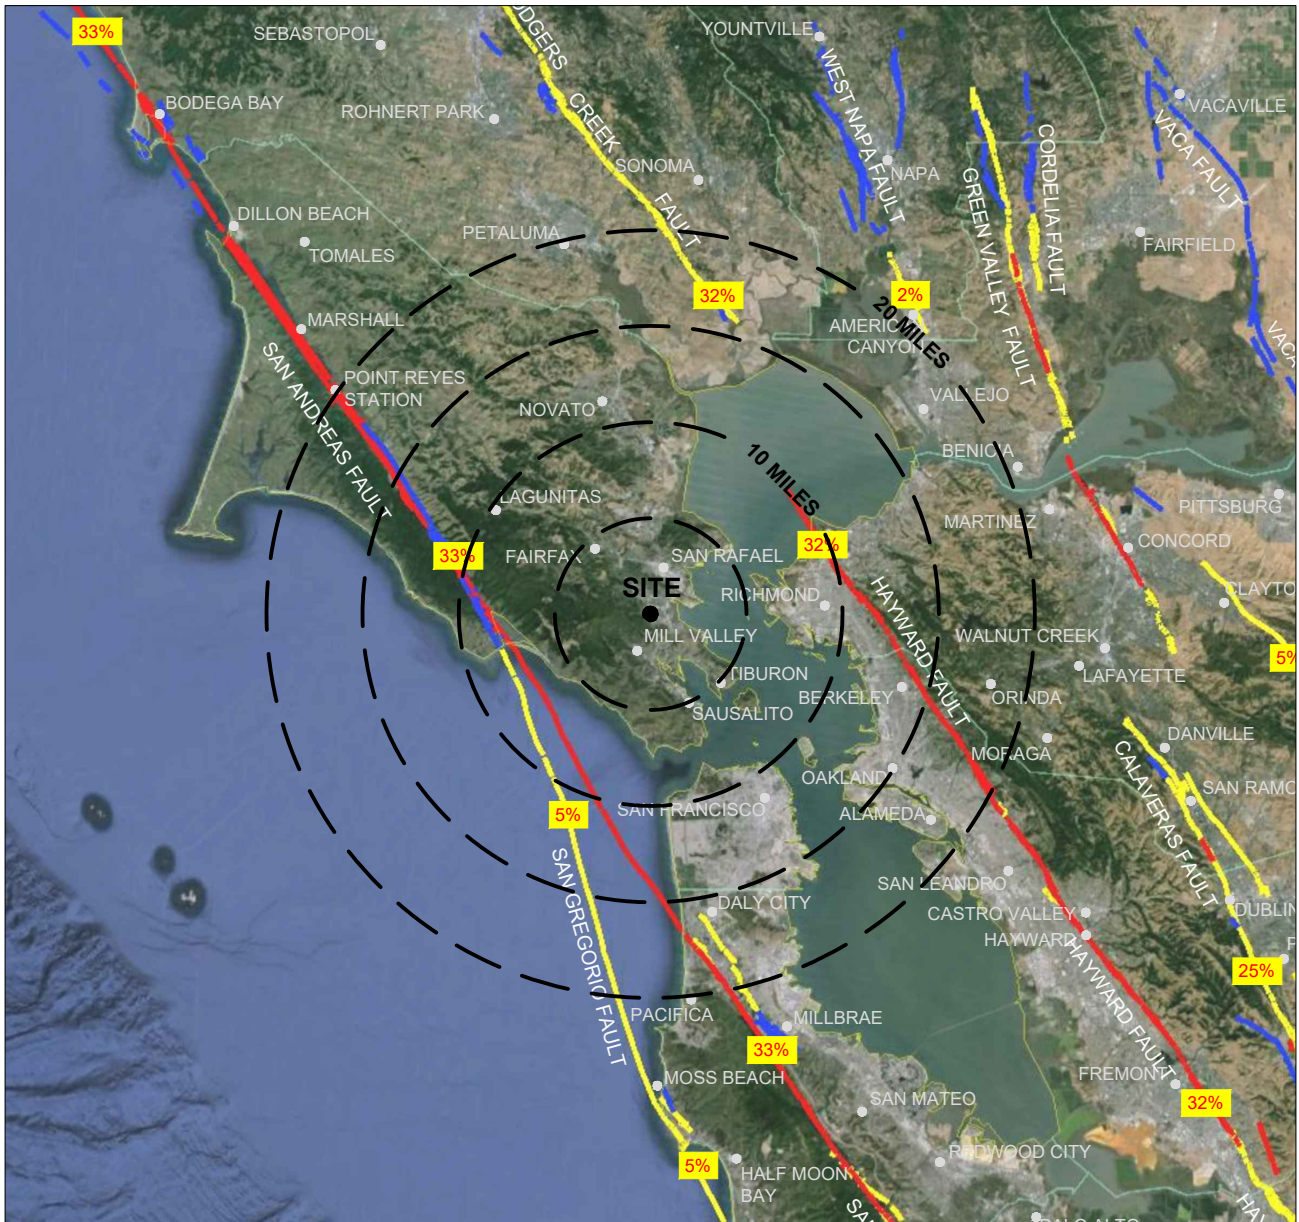
SITE COORDINATES: LAT. 37.9338, LON. -122.5096

<p>Miller Pacific ENGINEERING GROUP</p>	504 Redwood Blvd. Suite 220 Novato, CA 94947 T 415 / 382-3444 F 415 / 382-3450 www.millerpac.com	<p>ACTIVE FAULT MAP</p>		<p>Drawn <u>MMT</u> Checked</p>	<p style="font-size: 2em; font-weight: bold;">9</p> <p>FIGURE</p>
	<p>Wetland Restoration Design and Permitting Support Services at Corte Madera Ecological Reserve, PSA 2014-FT-13</p>		<p>Project No. 1039.051 Date: 8-21-15</p>		
<p>A CALIFORNIA CORPORATION, © 2013, ALL RIGHTS RESERVED FILE: 1039.051 FM.dwg</p>

The site will likely experience seismic ground shaking similar to other areas in Marin County with underlying bay mud in the seismically active San Francisco Bay Area. Earthquakes along several active faults in the region, as shown on the Fault Map Figure 9, could cause moderate to strong ground shaking at the site. Estimates of peak ground accelerations are based on either deterministic or probabilistic methods.

Minimum mitigation of seismic ground shaking includes design of any proposed new structures in conformance to the provisions of the most recent edition (2013) of the California Building Code. The magnitude and character of these ground motions will depend on the particular earthquake and the site response characteristics. Based on the interpreted subsurface conditions and close proximity of the San Andreas Fault, the MPEG recommends the CBC coefficients and site values shown in Table C below to calculate the design base shear of the new construction. To determine site seismic coefficients, the MPEG used latitude and longitude coordinates shown on Figure 9.

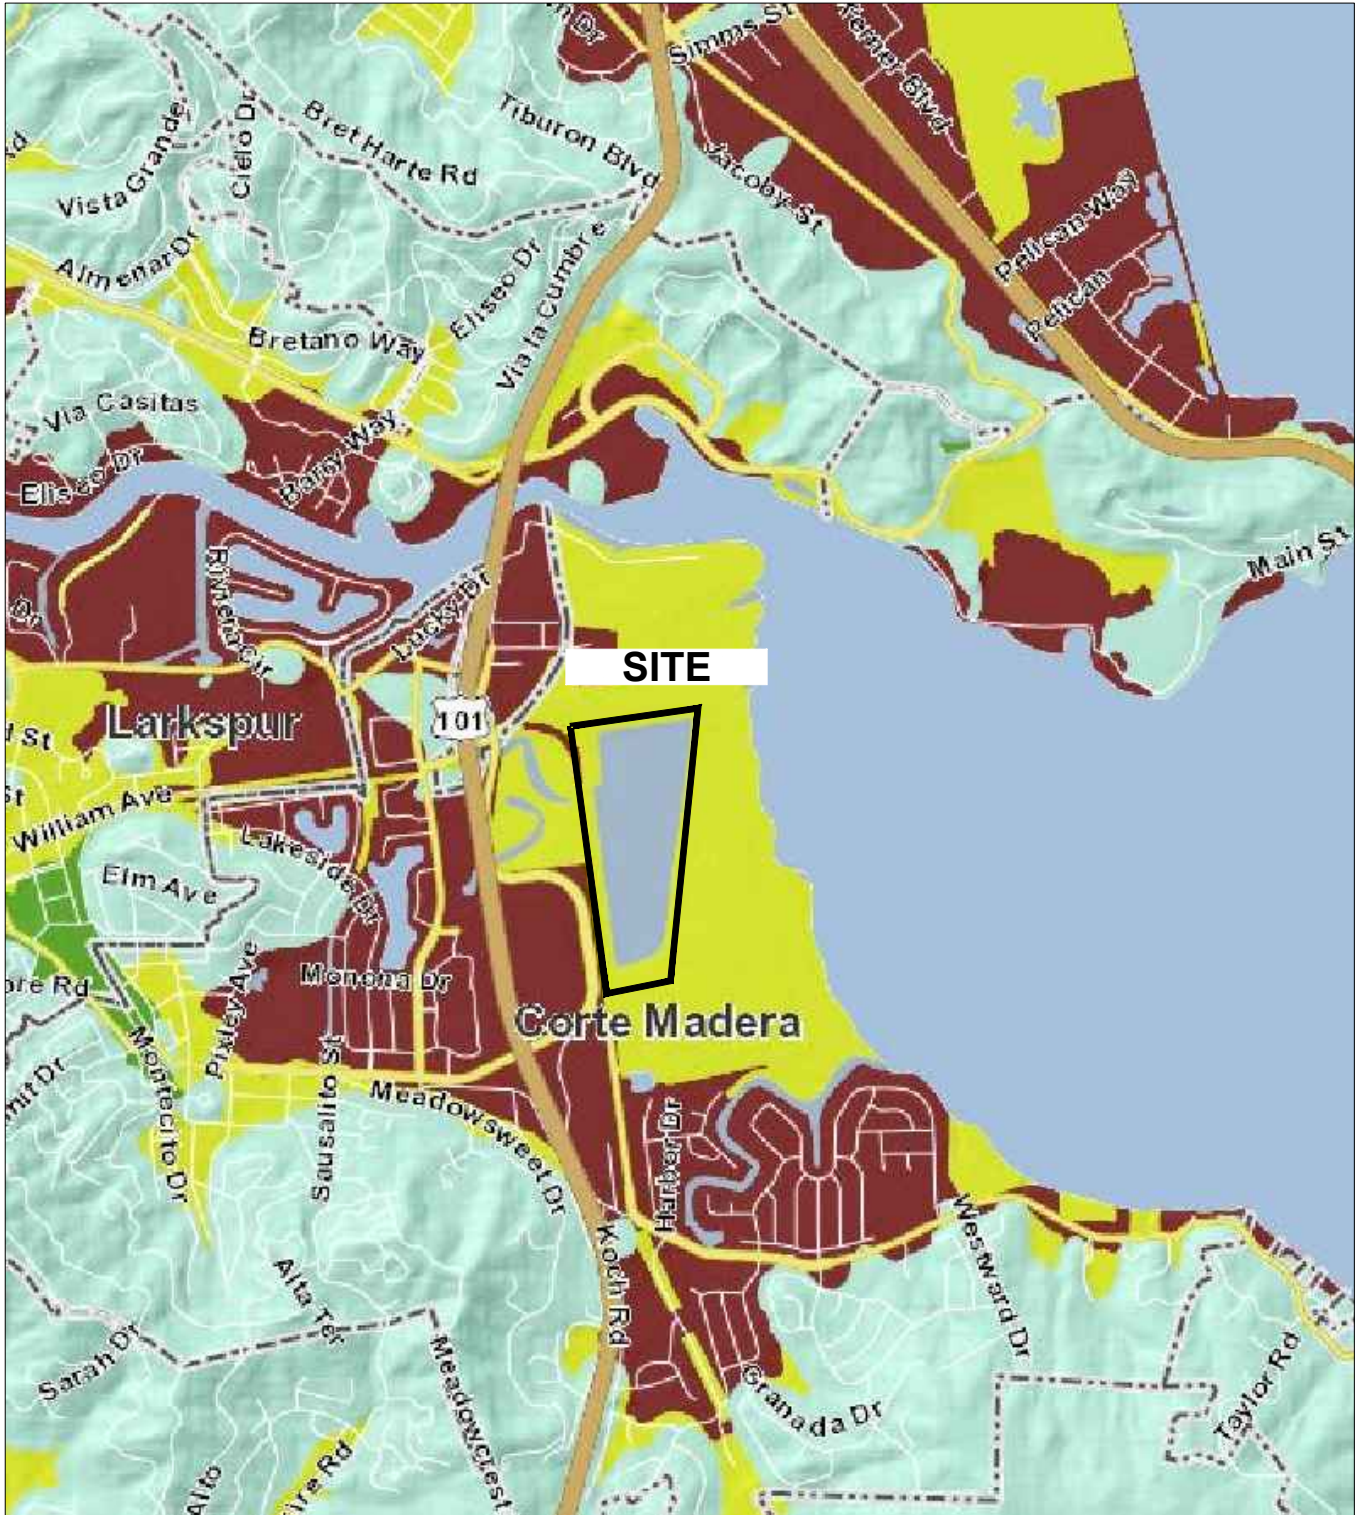
Susceptibility Level: ■ Very High ■ Moderate ■ Very Low Local Road
■ High ■ Low Major Road

Miller Pacific ENGINEERING GROUP	504 Redwood Blvd. Suite 220 Novato, CA 94947 T 415 / 382-3444 F 415 / 382-3450 www.millerpac.com	LIQUEFACTION SUSCEPTIBILITY MAP		10 FIGURE
	Wetland Restoration Design and Permitting Support Services at Corte Madera Ecological Reserve, PSA 2014-FT-13 Project No. 1039.051 Date: 8-27-15		Drawn <u>MMT</u> Checked

Liquefaction refers to the sudden, temporary loss of soil shear strength during strong ground shaking. Liquefaction-related phenomena include liquefaction-induced settlement, flow failure, and lateral spreading. These phenomena can occur where there are saturated, loose, granular deposits. As shown on Figure 10, in regards to liquefiable material, the site is mapped as a water body with all of the surrounding areas mapped as having moderate liquefaction susceptibility. Loose saturated sand layers were not encountered in the subsurface exploration. Therefore, the risk of damage to future improvements due to liquefaction is low.

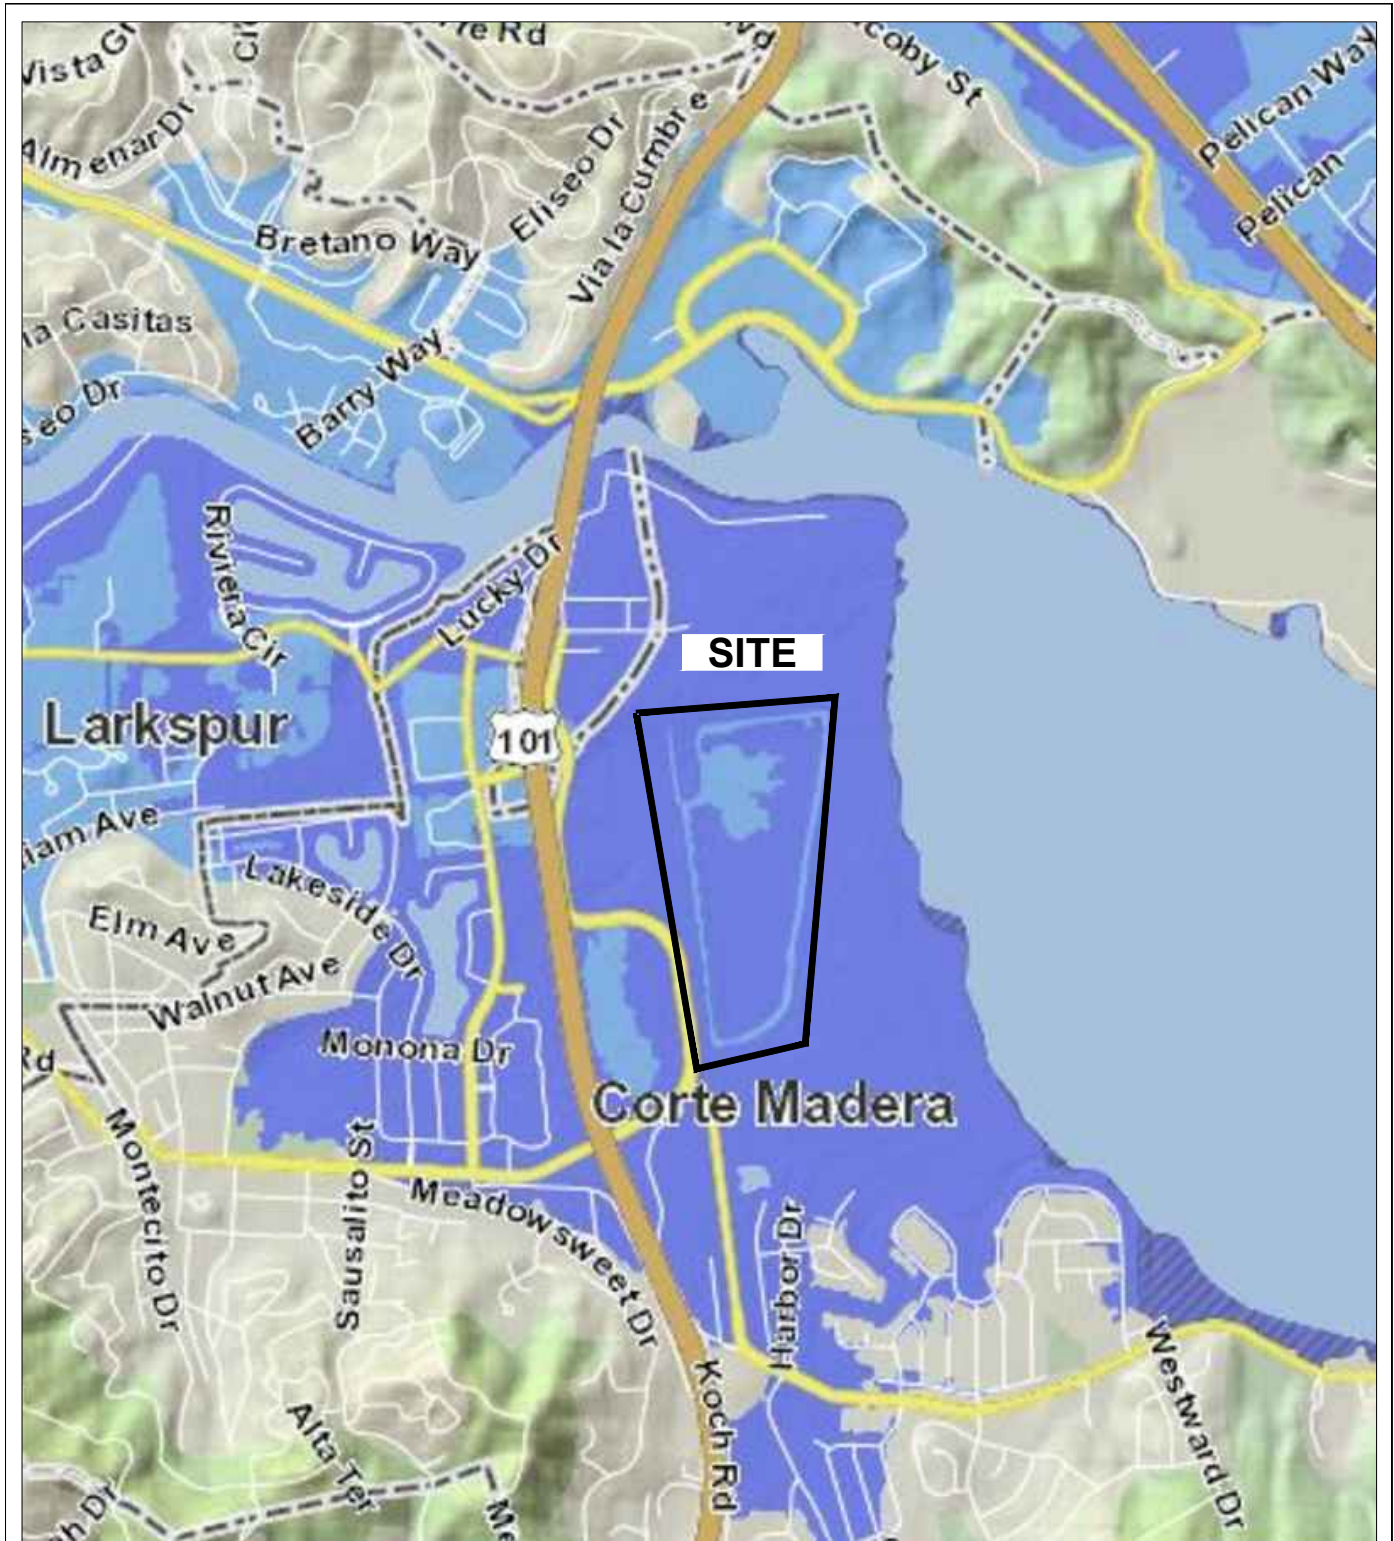
11
 FIGURE

Flood Hazard Area:

- Zone V - 100yr.
- Zone X - 500yr.
- Zone A - 100yr.
- Urbanized Area

The adverse impact from flooding is water damage to structures. The project site is located within a FEMA 100-year flood zone as shown on Figure 11. Therefore, the risk of damage to improvements due to large scale flooding is moderate. Potential for flooding is significant; however, since no improvements would be damaged by flood waters, potential for significant damage to improvements appears low.

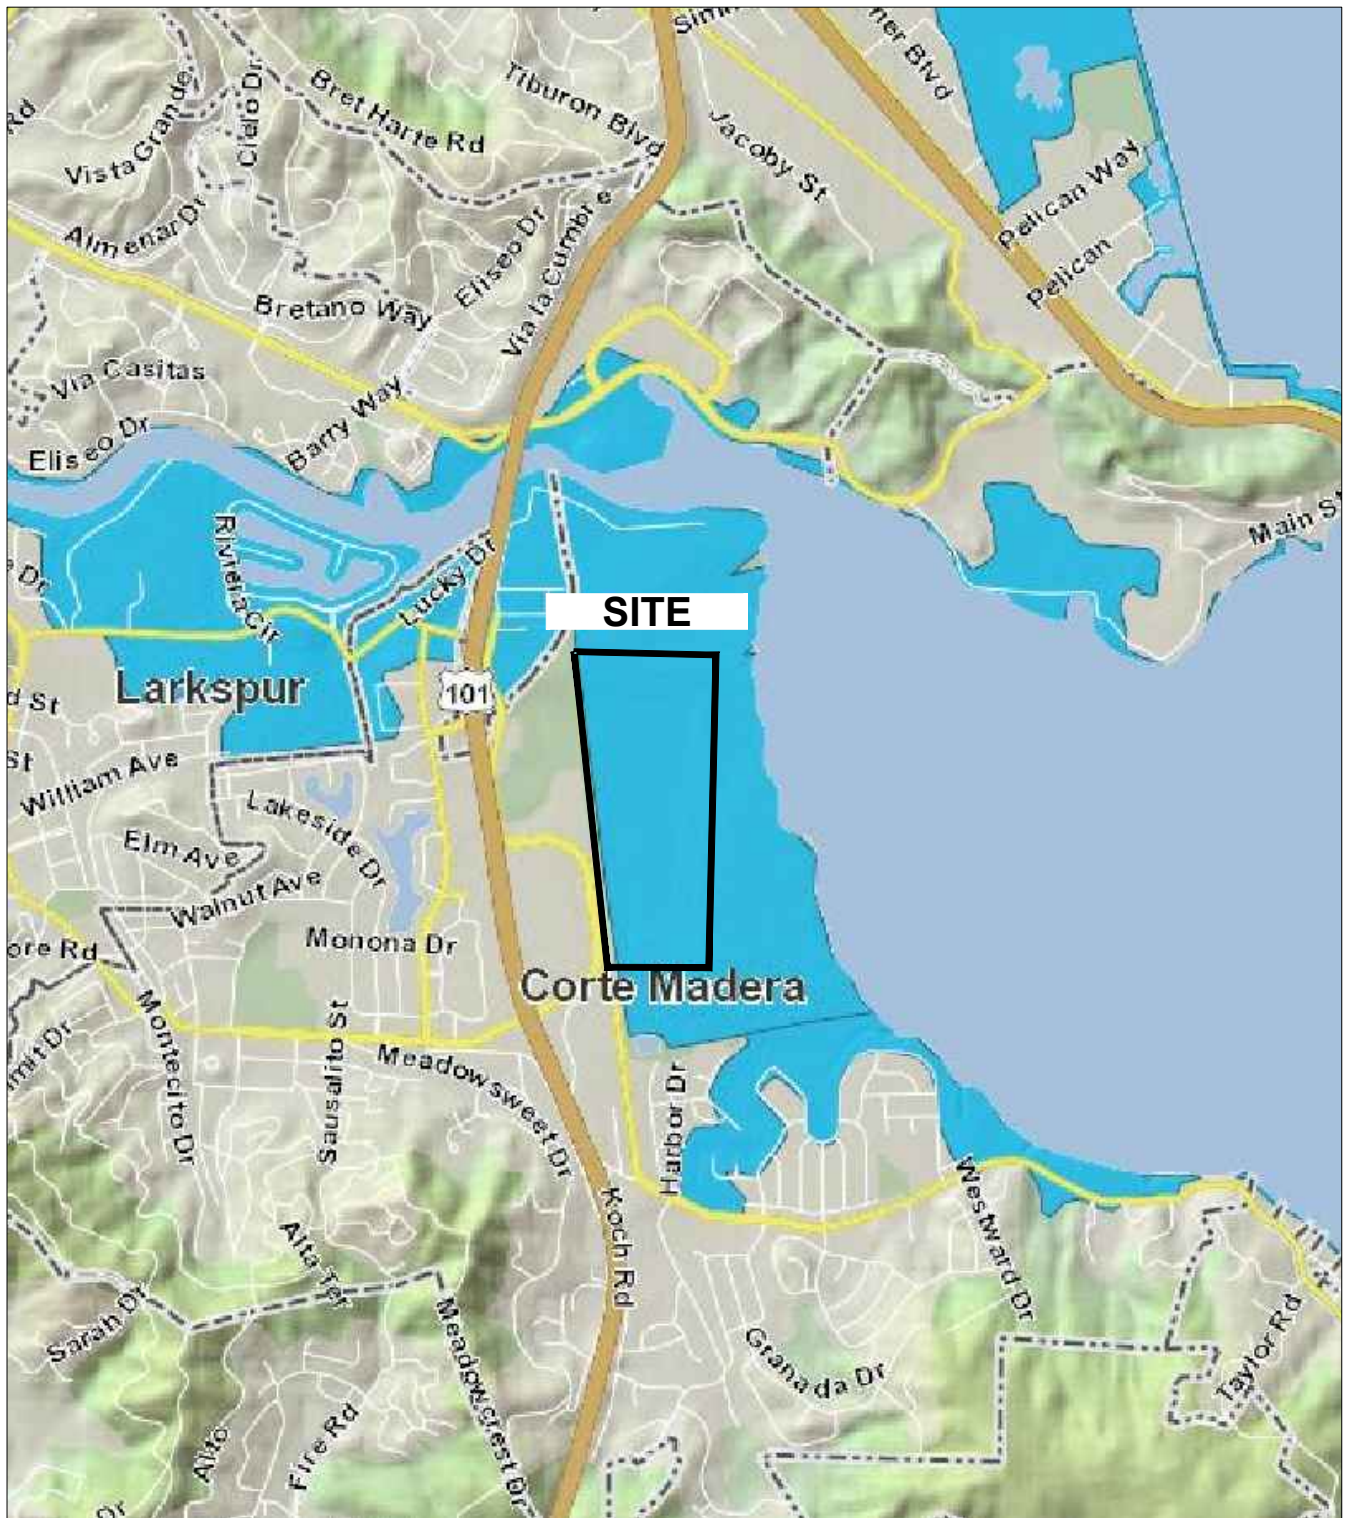
Tsunami Inundation:

- Tsunami Inundation Area
- Urbanized Area

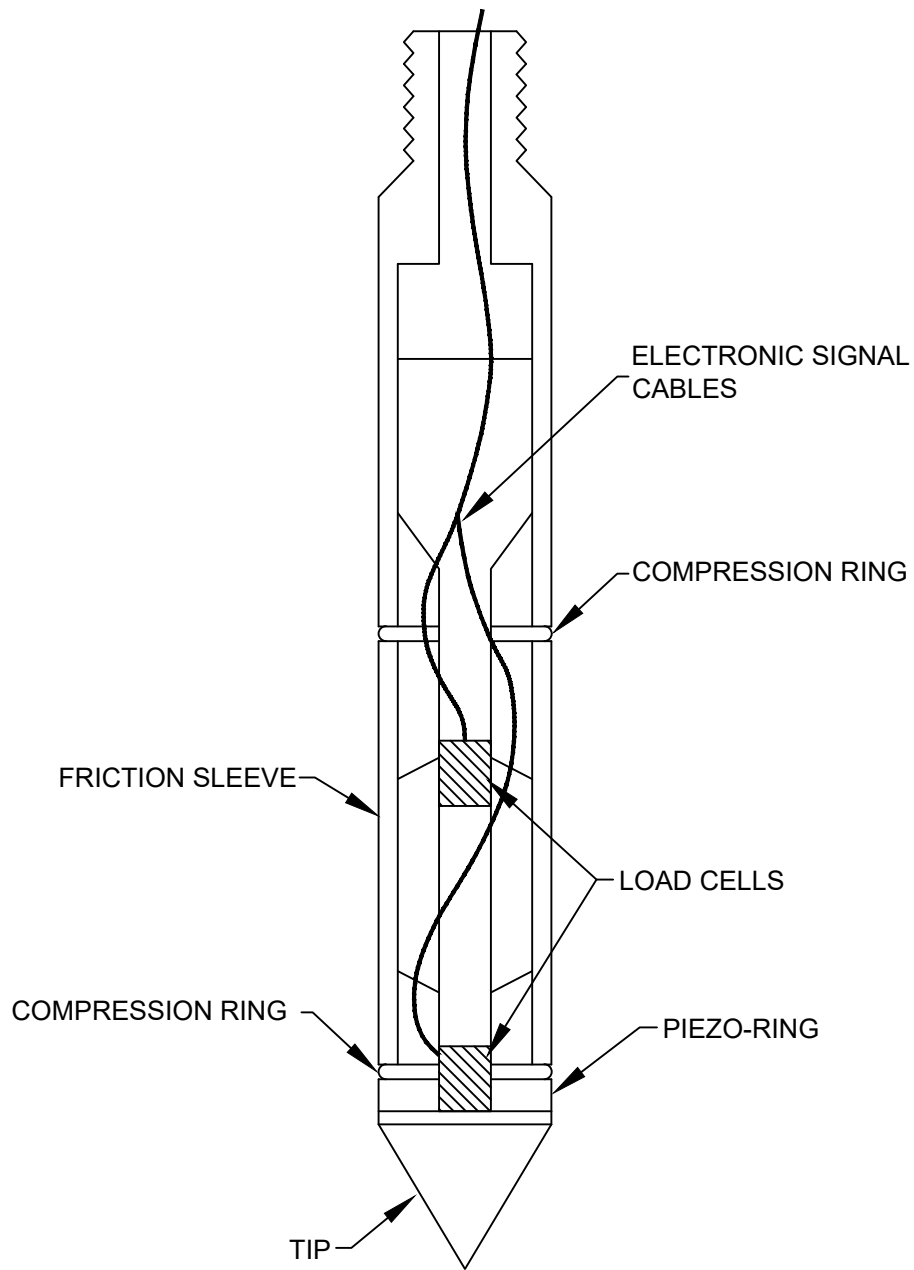
Miller Pacific ENGINEERING GROUP	504 Redwood Blvd.	CONE PENETROMETER		<div style="font-size: 2em; font-weight: bold; margin: 0;">A-5</div> FIGURE
	Suite 220	Novato, CA 94947	T 415 / 382-3444	
A CALIFORNIA CORPORATION, © 2008, ALL RIGHTS RESERVED FILE: 1039.051 CPT.dwg	www.millerpac.com	Wetland Restoration Design and Permitting Support Services at Corte Madera Ecological Reserve, PSA 2014-FT-13	Drawn <u>MMT</u> Checked	
		Project No. 1039.051	Date: 2/2/15

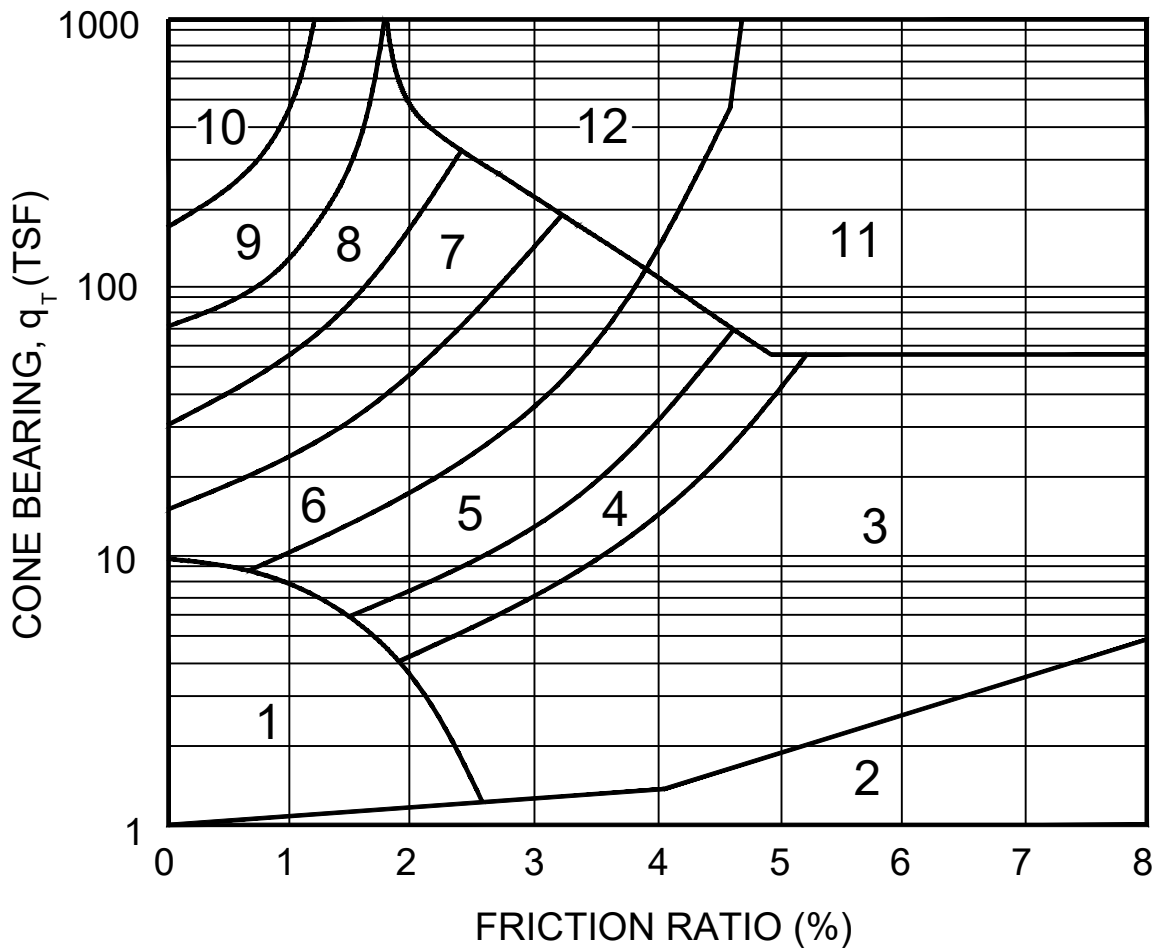
Zone:	Q_c/N	Soil Behavior Type:
1)	2	Sensitive Fine Grained
2)	1	Organic Material
3)	1	Clay
4)	1.5	Silty Clay to Clay
5)	2	Clayey Silt to Silty Clay
6)	2.5	Sandy Silt to Clayey Silt
7)	3	Silty Sand to Sandy Silt
8)	4	Sand to Silty Sand
9)	5	Sand
10)	6	Gravelly Sand to Sand
11)	1	Very Stiff Fine Grained (*)
12)	2	Sand to Clayey Sand (*)

(*) Overconsolidated or Cemented

Miller Pacific ENGINEERING GROUP A CALIFORNIA CORPORATION, © 2008, ALL RIGHTS RESERVED FILE: 1039.051 CPT.dwg	504 Redwood Blvd. Suite 220 Novato, CA 94947 T 415 / 382-3444 F 415 / 382-3450 www.millerpac.com	CPT SOIL INTERPRETATION CHART		Drawn <u>MMT</u> Checked	A-6 FIGURE
	Wetland Restoration Design and Permitting Support Services at Corte Madera Ecological Reserve, PSA 2014-FT-13 Project No. 1039.051 Date: 2/2/15

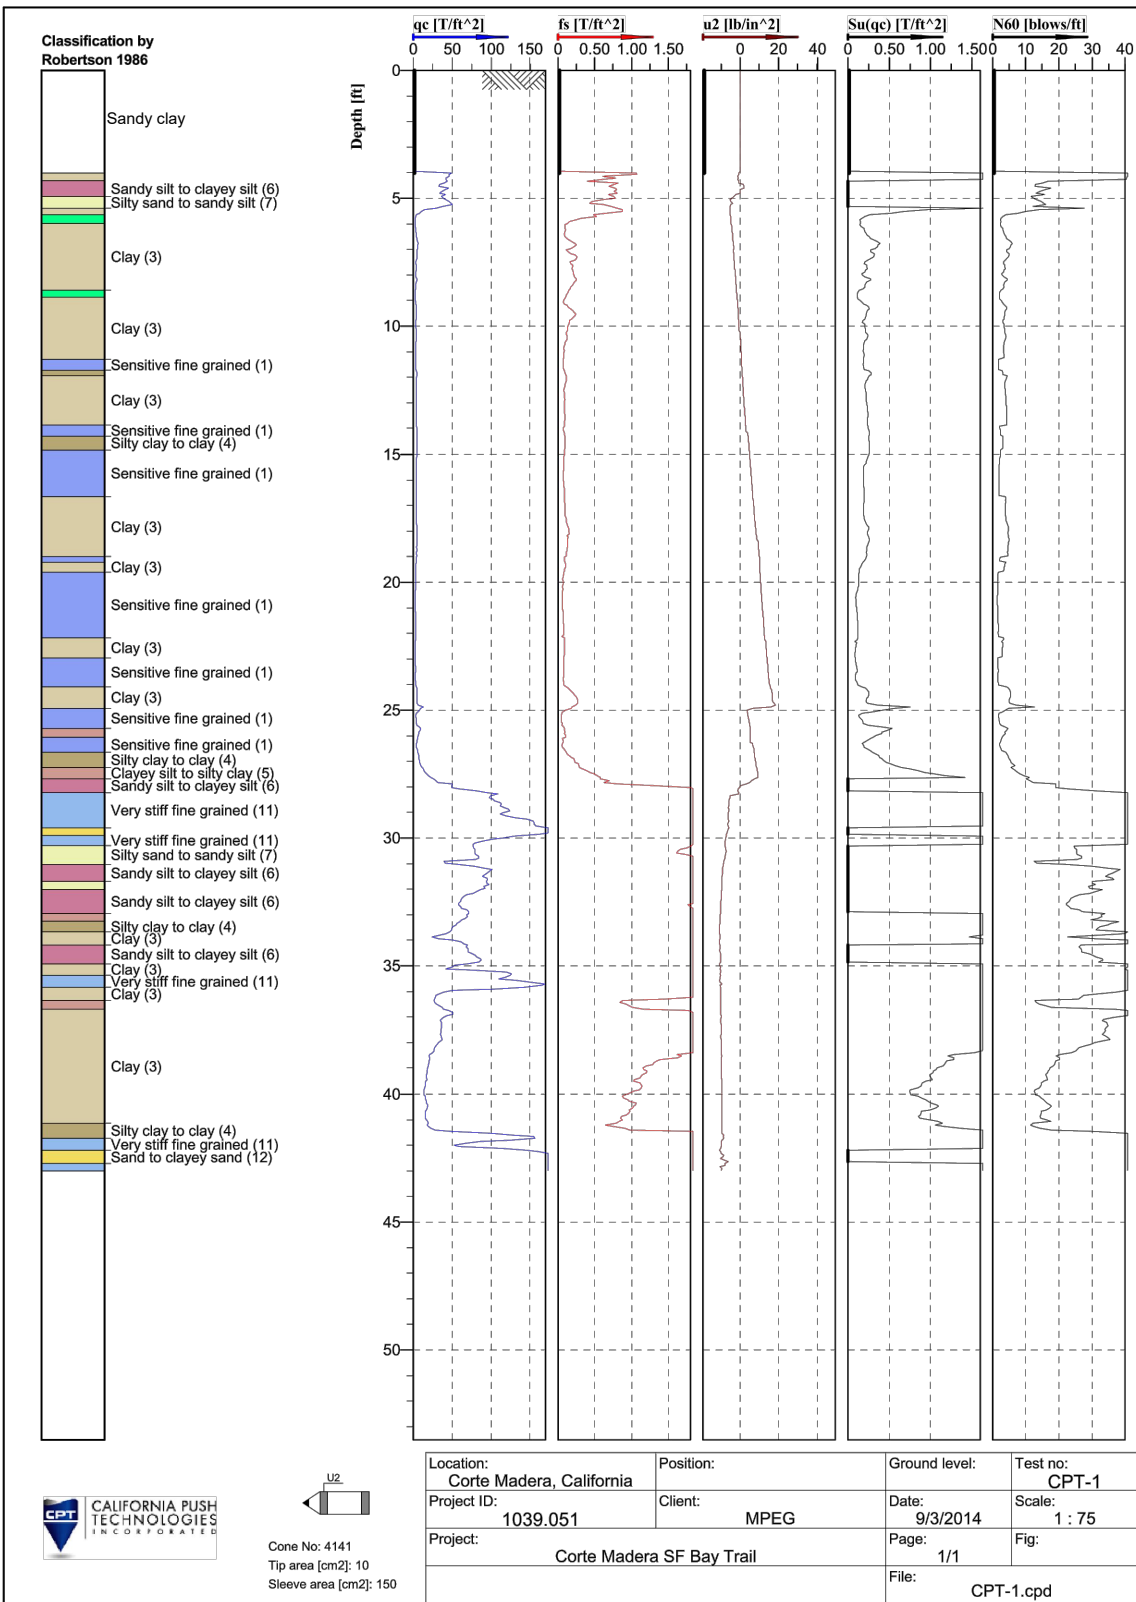
A-7
FIGURE

Cone No: 4141
 Tip area [cm²]: 10
 Sleeve area [cm²]: 150

Subsurface conditions across the site generally confirm the regionally-mapped geology. Approximately 5 to 10-feet of sandy silty clay fill material exists above approximately 20 to 40-feet of bay mud, followed by medium stiff to stiff alluvial clays that extend in excess of 50-feet below the ground surface. Exploration did not extend beyond 50-feet. The interpreted thickness of the bay mud layer varies across the site as shown on Figure 2. The existing perimeter levee is composed of medium stiff, clayey soils that transition to soft bay mud at a depth of about 10 feet. CPT and boring logs are attached in Appendix A.
